ADA TRANSITION PLAN 2017 SUPPLEMENT

Supplement to the ADA Transition Plan

Accessibility for Public Right-of-Way and Exterior Accessible Routes for Buildings University of Illinois at Urbana-Champaign May 2017

Prepared by Facilities & Services, Engineering and Construction Services Division

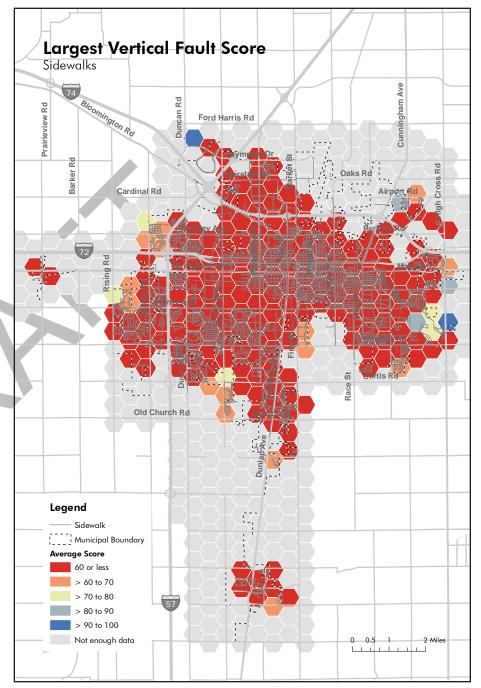
Figure 4-3 Sidewalk Vertical Fault Size Scores

Less than 12 percent of sidewalks by length met the PROWAG standard for the largest vertical fault. However, about 38 percent of sidewalk had vertical faults between $\frac{1}{4}$ inch and $\frac{1}{2}$ inch, which could be addressed using beveling. The remaining half of sidewalks by length had larger faults that would require more extensive repairs, such as concrete leveling or replacement of panels.

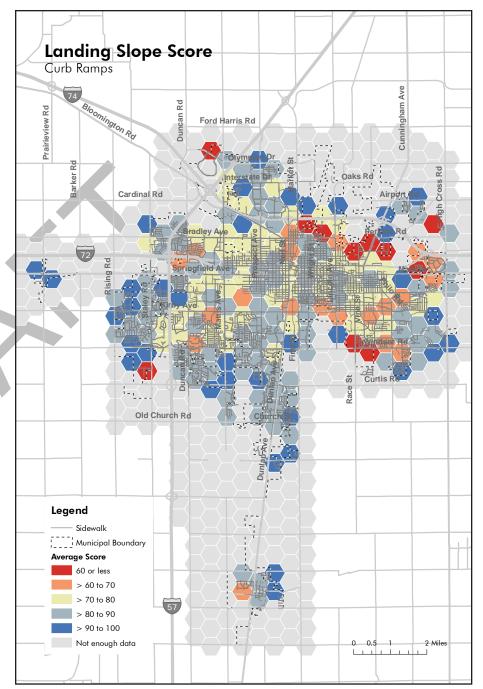
Figure 4-16 Curb Ramp Landing Slope Scores

Landing cross slopes were most problematic in the older core of the urbanized area (see *Figure 4-16*). However, the highest concentrations of noncompliance were observed in north and south Champaign and Urbana. Southwest Champaign, southeast Urbana, Savoy, and Tolono had the highest levels of landing slope compliance.

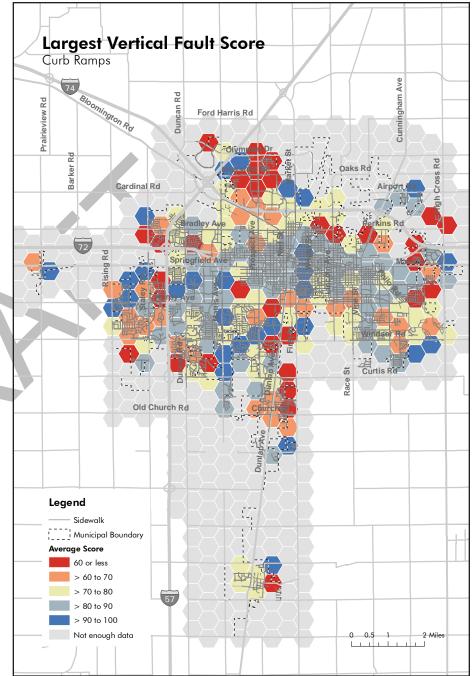
Figure 4-19 Curb Ramp Vertical Fault Size Scores

Vertical fault compliance scores for curb ramps were highest in the central part of the urbanized area, including the downtowns of Champaign and Urbana and the University of Illinois campus area (see *Figure 4-19*). Clusters of noncompliance were scattered throughout the outer parts of the urbanized area, most notably in the North Prospect Avenue commercial district in Champaign.

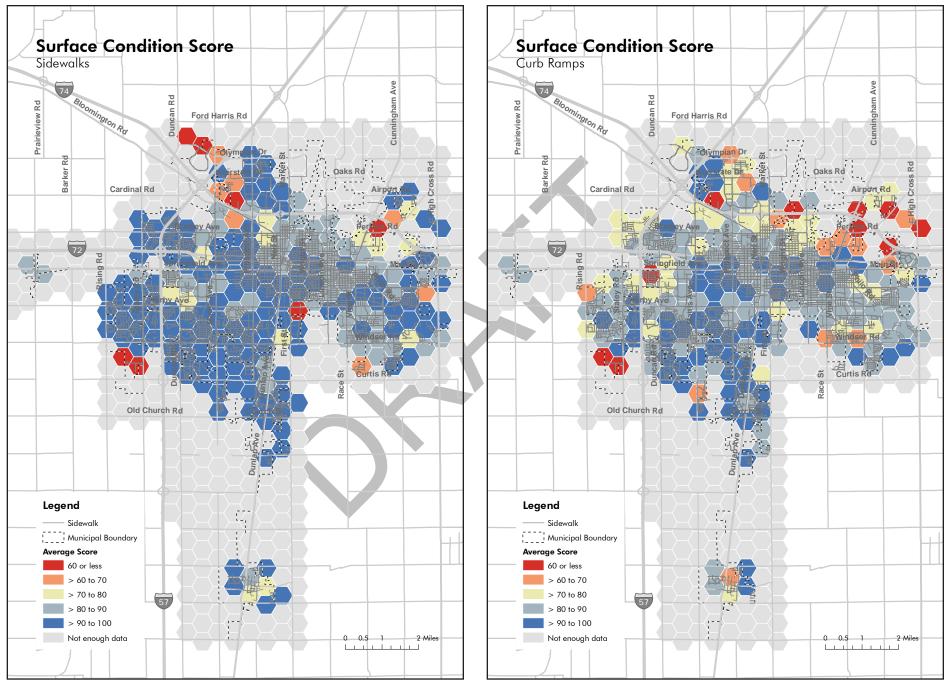
Figure 5-1 Sidewalk Surface Condition Scores

More than three quarters of sidewalks by length did not have significant surface condition issues. Of those that did, cracking and grass were the most common issues, affecting approximately 9 and 7 percent of sidewalks, respectively.

In some cases surface condition issues on curb ramps coincided with surface condition problem on sidewalks. In other areas, particularly in areas west of I-57 and in the northeast corner of the urbanized area, curb ramp surface condition issues occurred in the absence of significant sidewalk surface condition problems. This spatial mismatch reflects differences in the types of issues affecting sidewalks and curb ramps. Sidewalks surfaces were more likely to suffer from structural defects, such as spalling and cracking, while curb ramp surfaces were more likely to experience maintenance-related issues, such as dirt and grass.

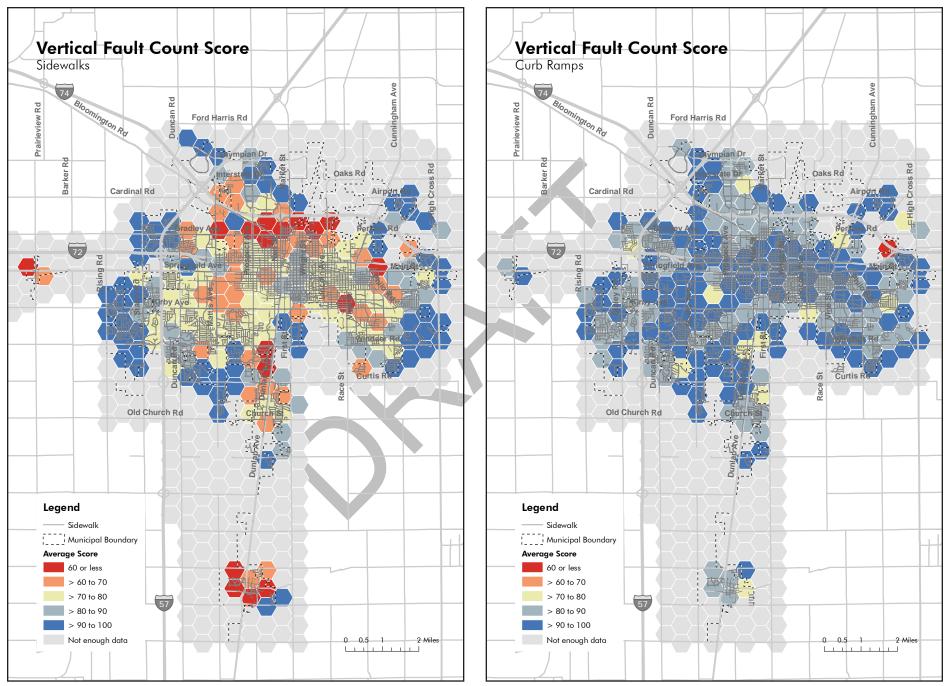
Figure 5-3 Sidewalk Vertical Fault Frequency Scores

Areas with frequent curb ramp vertical faults were somewhat more scattered, though the I-74 corridor also had a higher concentration of curb ramps with vertical faults than most other parts of the urbanized area (see Figure 5-4). The lack of strong spatial correlation between vertical faults in sidewalks and curb ramps suggested that different factors may influence the formation of faults in these feature types.

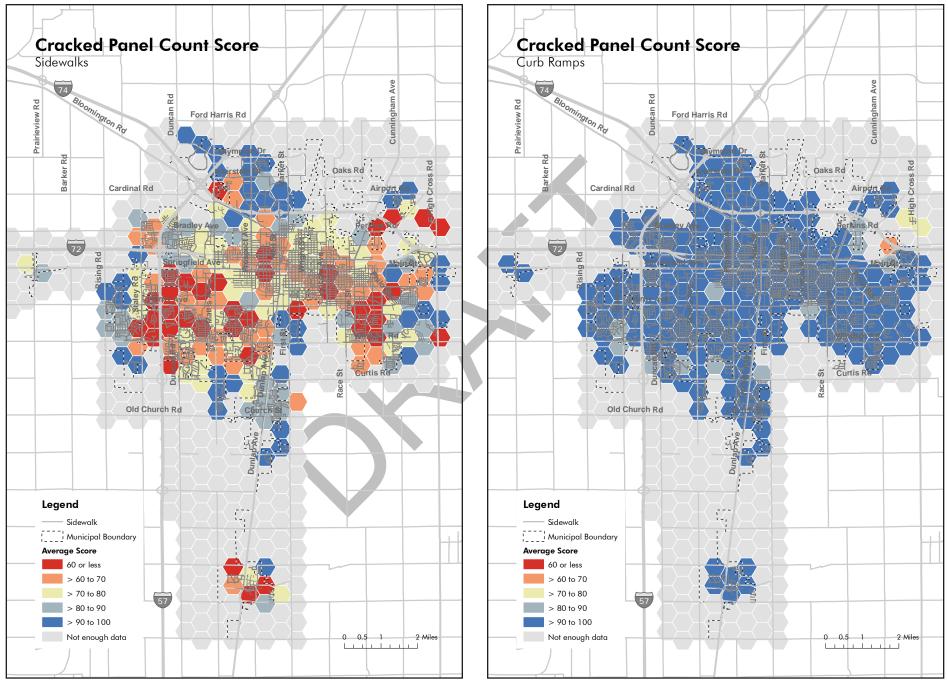
Figure 5-5 Sidewalk Cracked Panels Scores

More than 38 percent of sidewalks by length scored in the highest tier for cracked panels, with less than 2.5 percent of panels showing cracking. Sidewalks were fairly evenly distributed among the remaining score tiers, with approximately 17 percent of sidewalks exhibiting cracking in 10 percent or more of panels.

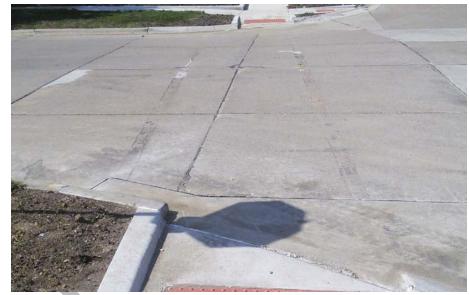
In this crosswalk, the standard painted markings and the stop bar are worn, almost to the point of being unrecognizable.

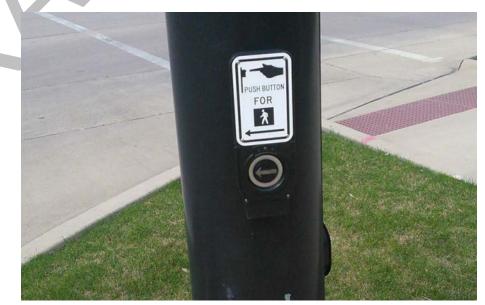
This pushbutton has a variety of accessibility features and appears to be in good condition, but field staff noted that it was not operable.
