AHERA Work Permit – F&S and Tech Services

#21 KENNEY GYM

ASBESTOS INSPECTION FOR

#5 KENNEY GYM ANNEX

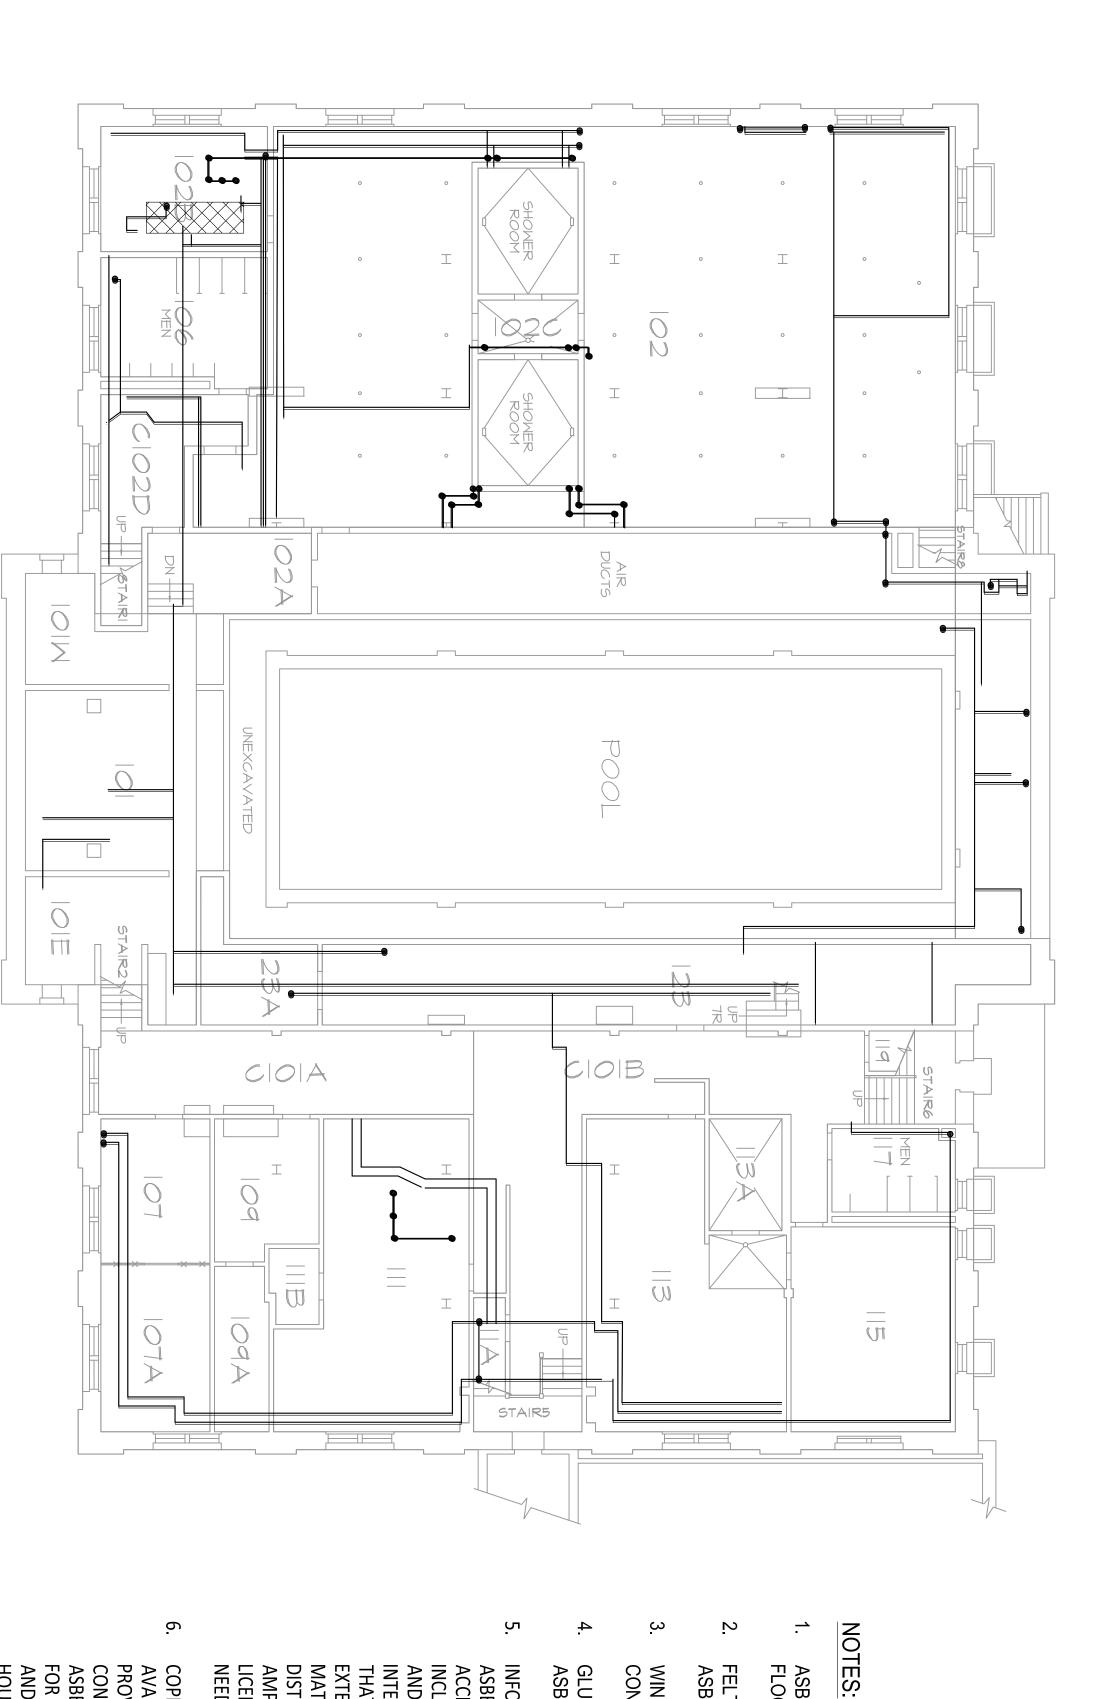
SBESTOS INSPECTION FOR	FIRST FLOOR
------------------------	-------------

ASBESTOS MASTIC UNDER RUBBER TRACK
ASBESTOS HOT WATER TANK INSULATION

- 1. ASBESTOS FLOORING MATERIALS UNDER FLOATING PLASTIC FLOOR IN LOCKER ROOM 208, 208B, AND 208C.
- 2. FELT PAPER UNDER HARDWOOD FLOORS IS ASSUMED ASBESTOS CONTAINING

- WINDOW CAULK ON EXTERIOR WINDOWS IS ASBESTOS CONTAINING.
- GLUE PADS BEHIND MIRROR IN ROOM 310 ARE ASSUMED ASBESTOS CONTAINING.
- ASBESTOS MANAGEMENT PLANS (AMPS) IS LIMITED TO ACCESSIBLE MATERIALS IN INTERIOR SPACES. INTERIOR SPACES INCLUDE EXTERIOR HALLWAYS CONNECTING BUILDINGS, PORCHES AND PORTICOS, AND MECHANICAL SYSTEMS USED TO CONDITION INTERIOR SPACE. THE FOLLOWING ARE EXAMPLES OF MATERIALS THAT MAY BE EXCLUDED: EXTERIOR CAULKING AND GLAZING, EXTERIOR EXPANSION JOINTS, ROOFING MATERIALS, AND MATERIALS THAT MAY BE HIDDEN IN WALL CAVITIES. PRIOR TO DISTURBING THE MATERIALS EXCLUDED FROM THE MAPS AND AMPS A THOROUGH INSPECTION MUST BE PERFORMED BY A LICENSED ASBESTOS BUILDING INSPECTOR AND SAMPLES MAY NEED TO BE COLLECTED AND ANALYZED.

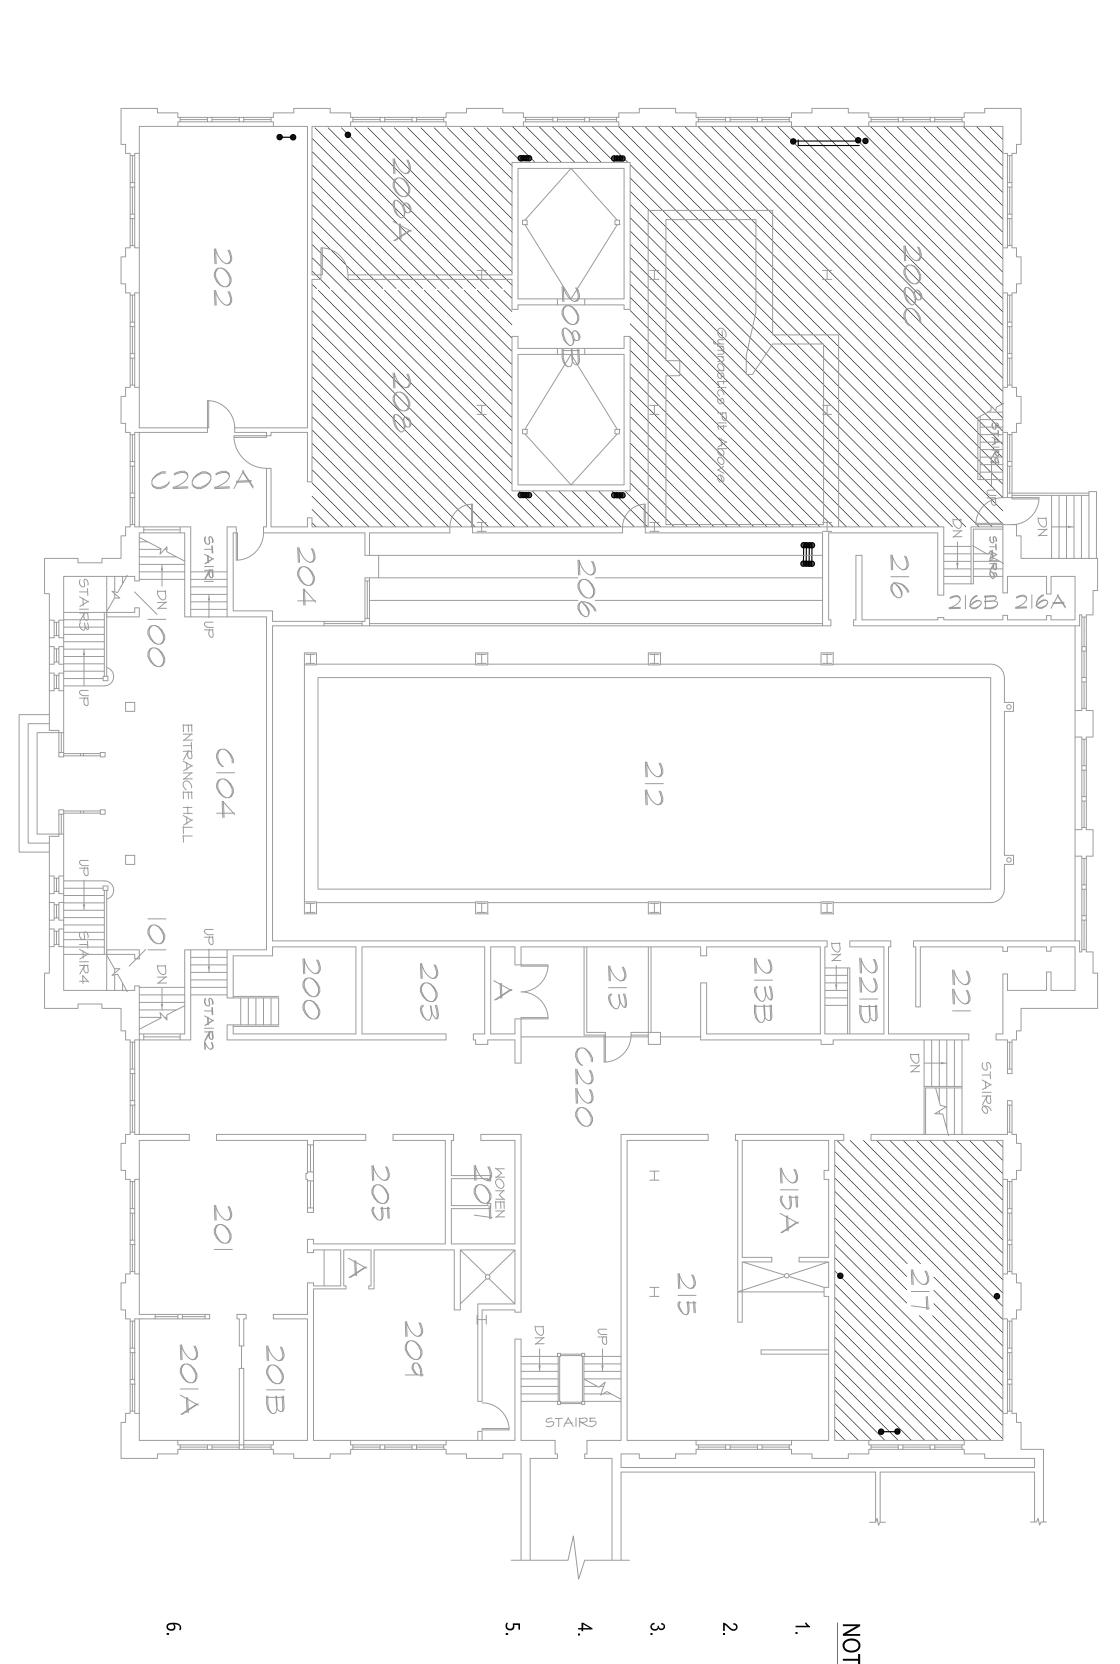
ASBESTOS INSPECTION	SECOND FLOC
TION FOR	OOR

- ASBESTOS FLOORING MATERIALS UNDER FLOATING PLASTIC FLOOR IN LOCKER ROOM 208, 208B, AND 208C.
- FELT PAPER UNDER HARDWOOD FLOORS IS ASSUMED ASBESTOS CONTAINING

- CONTAINING. WINDOW CAULK ON EXTERIOR WINDOWS IS ASBESTOS
- GLUE PADS BEHIND MIRROR IN ROOM 310 ARE ASSUMED ASBESTOS CONTAINING.
- EXTERIOR EXPANSION JOINTS, ROOFING MATERIALS, AND INFORMATION PROVIDED IN THE AHERA MAPS AND AHERA NEED TO BE COLLECTED AND ANALYZED. LICENSED ASBESTOS BUILDING INSPECTOR AND SAMPLES MAY AND PORTICOS, AND MECHANICAL SYSTEMS USED TO CONDITION INTERIOR SPACE. THE FOLLOWING ARE EXAMPLES OF MATERIALS AMPS A THOROUGH INSPECTION MUST BE PERFORMED BY A DISTURBING THE MATERIALS EXCLUDED FROM THE MAPS AND MATERIALS THAT MAY BE HIDDEN IN WALL CAVITIES. PRIOR TO THAT MAY BE EXCLUDED: EXTERIOR CAULKING AND GLAZING, INCLUDE EXTERIOR HALLWAYS CONNECTING BUILDINGS, PORCHES ASBESTOS MANAGEMENT PLANS (AMPS) IS LIMITED TO ACCESSIBLE MATERIALS IN INTERIOR SPACES. INTERIOR SPACES

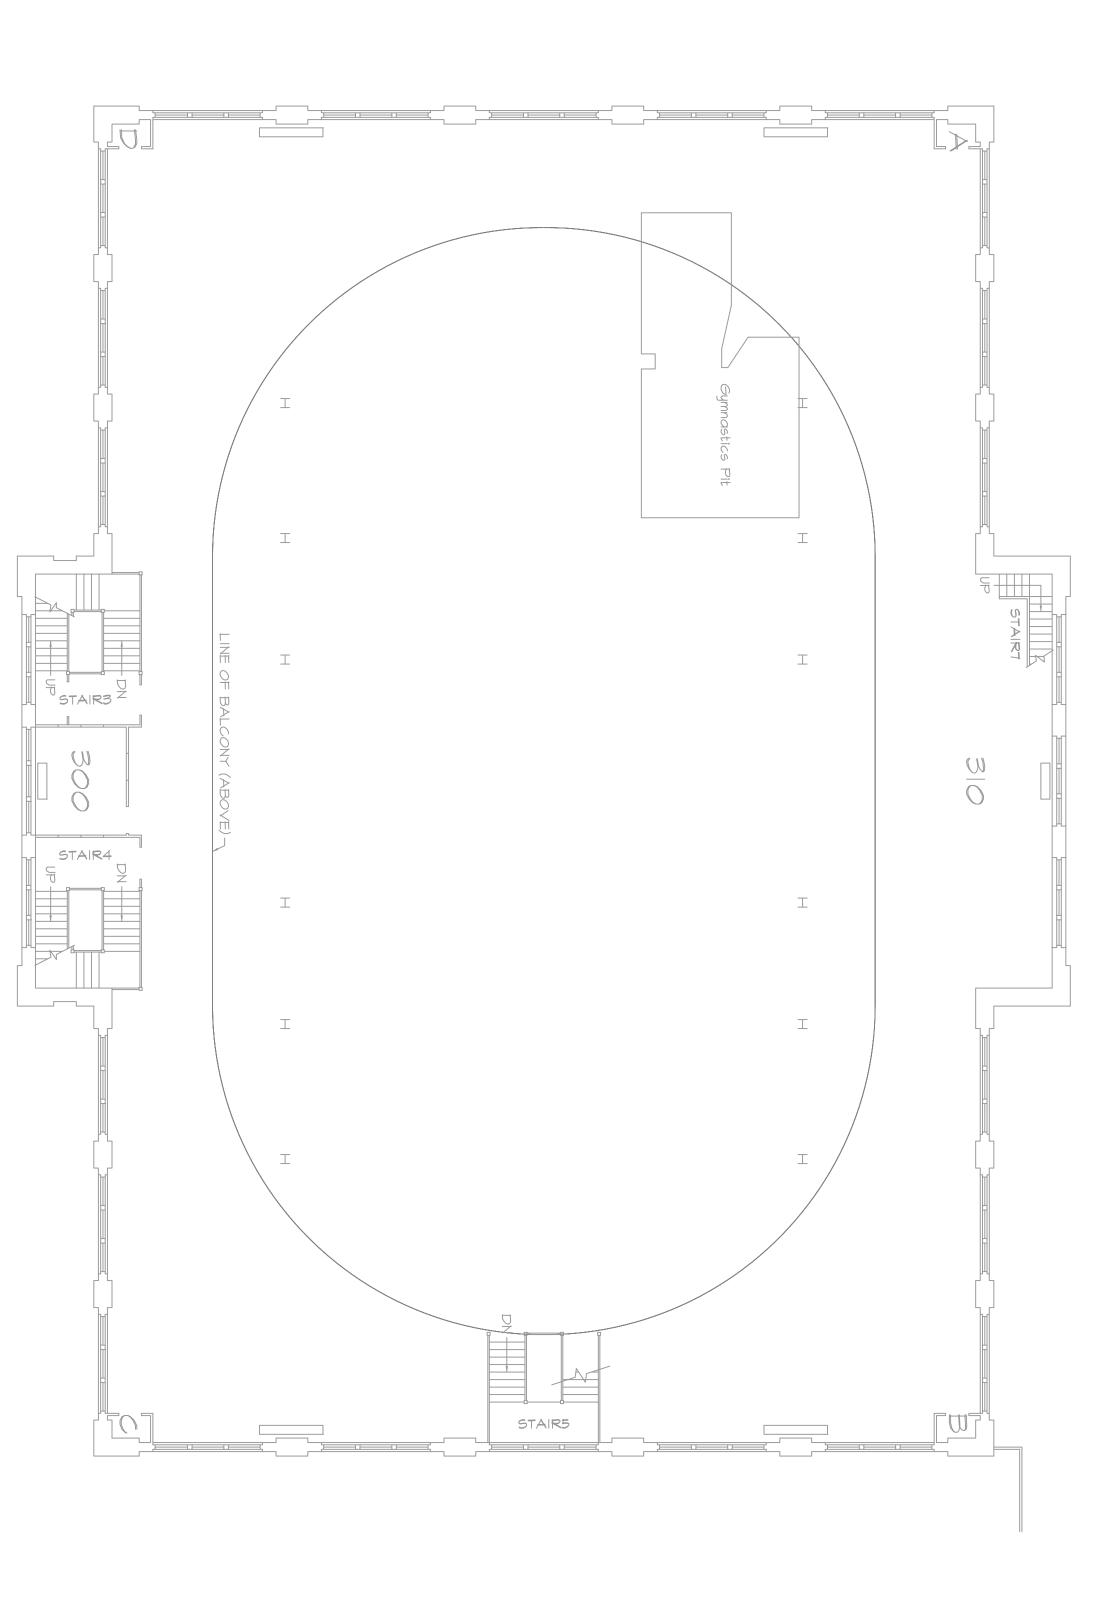
ASBESTOS INSPECTION FOR	THIRD FLOOR
-------------------------	-------------

ASBESTOS HOT WATER TANK INSULATION

ASBESTOS MASTIC UNDER RUBBER TRACK

(FLOOR TILE AND/OR MASTIC) ASBESTOS FLOORING MATERIALS ABESTOS PIPE AND FITTING INSULATION

- ASBESTOS FLOORING MATERIALS UNDER FLOATING PLASTIC FLOOR IN LOCKER ROOM 208, 208B, AND 208C.
- 2 FELT PAPER UNDER HARDWOOD FLOORS IS ASSUMED ASBESTOS CONTAINING

- ယ CONTAINING. WINDOW CAULK ON EXTERIOR WINDOWS IS ASBESTOS
- 4 GLUE PADS BEHIND MIRROR IN ROOM 310 ARE ASSUMED ASBESTOS CONTAINING.
- 5 EXTERIOR EXPANSION JOINTS, ROOFING MATERIALS, AND INFORMATION PROVIDED IN THE AHERA MAPS AND AHERA LICENSED ASBESTOS BUILDING INSPECTOR AND SAMPLES MAY AND PORTICOS, AND MECHANICAL SYSTEMS USED TO CONDITION INTERIOR SPACE. THE FOLLOWING ARE EXAMPLES OF MATERIALS NEED TO BE COLLECTED AND ANALYZED. AMPS A THOROUGH INSPECTION MUST BE PERFORMED BY A DISTURBING THE MATERIALS EXCLUDED FROM THE MAPS AND MATERIALS THAT MAY BE HIDDEN IN WALL CAVITIES. PRIOR TO THAT MAY BE EXCLUDED: EXTERIOR CAULKING AND GLAZING, INCLUDE EXTERIOR HALLWAYS CONNECTING BUILDINGS, PORCHES ASBESTOS MANAGEMENT PLANS (AMPS) IS LIMITED TO ACCESSIBLE MATERIALS IN INTERIOR SPACES. INTERIOR SPACES

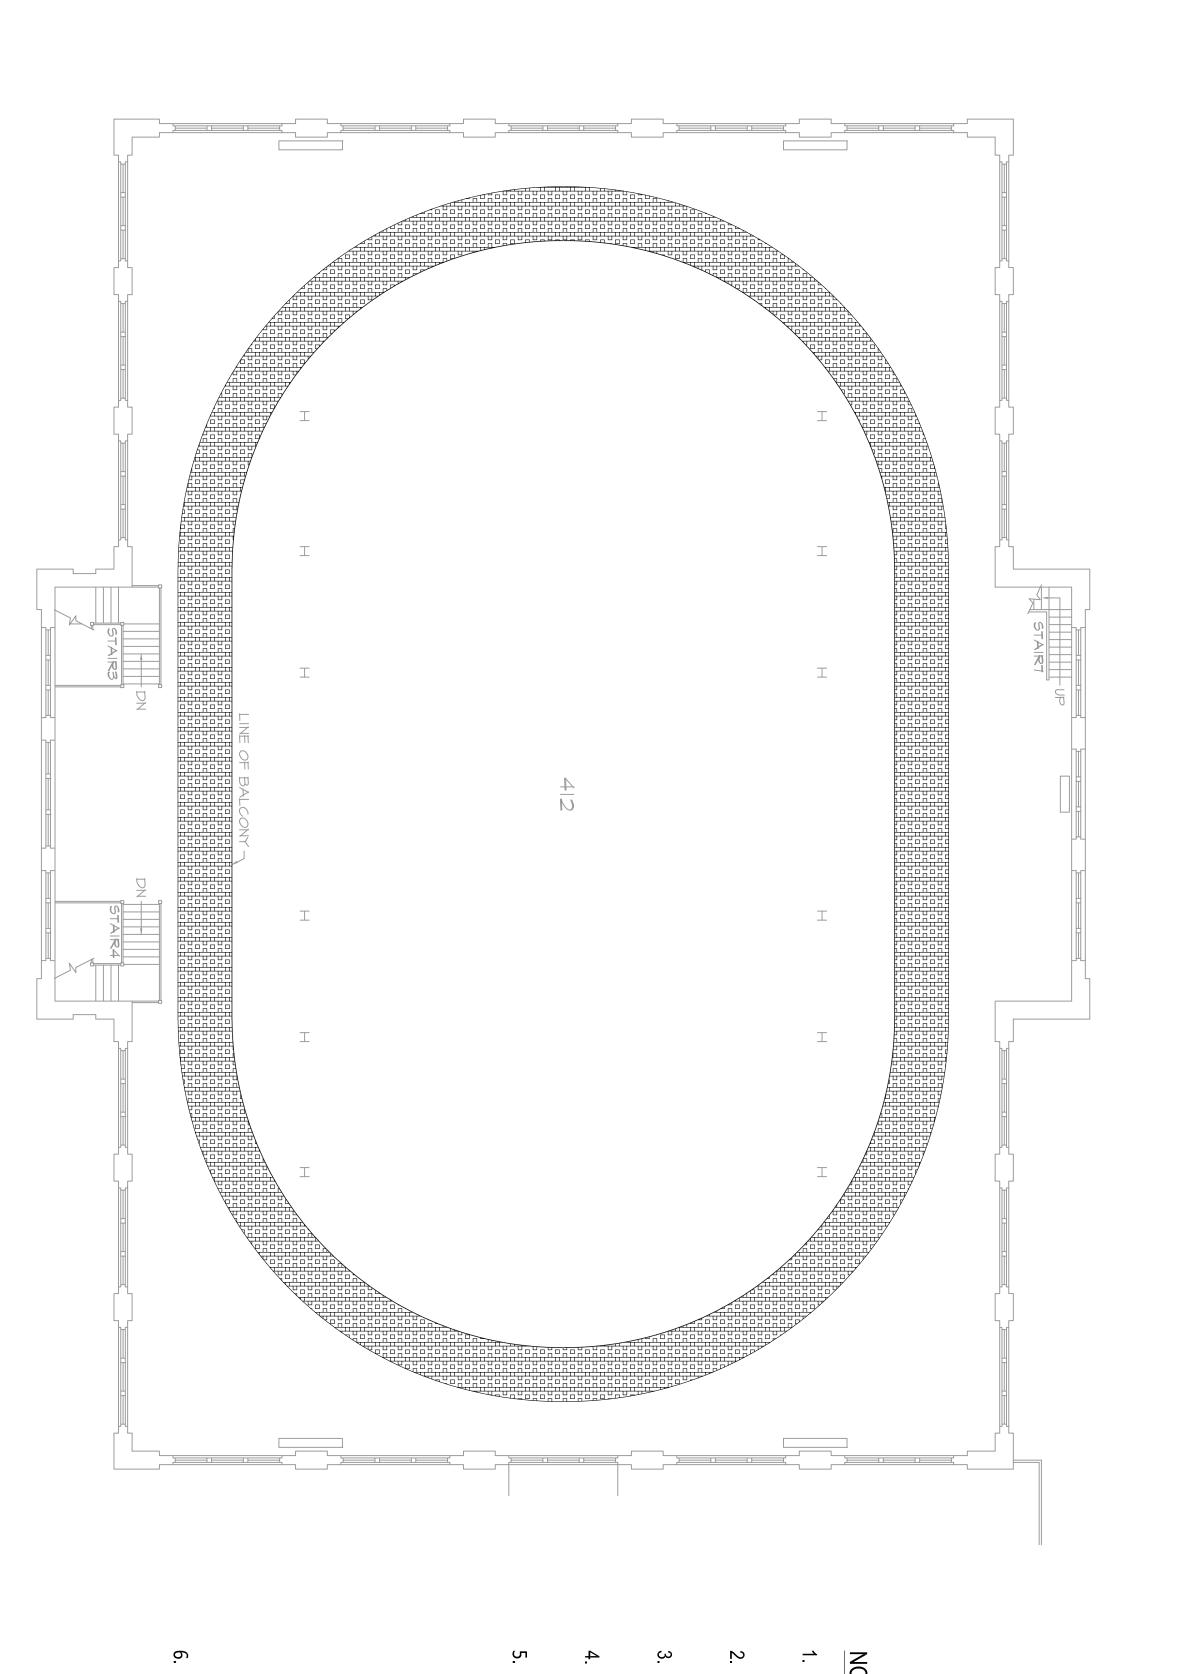
- ASBESTOS FLOORING MATERIALS UNDER FLOATING PLASTIC FLOOR IN LOCKER ROOM 208, 208B, AND 208C.
- FELT PAPER UNDER HARDWOOD FLOORS IS ASSUMED ASBESTOS CONTAINING

- CONTAINING. WINDOW CAULK ON EXTERIOR WINDOWS IS ASBESTOS
- GLUE PADS BEHIND MIRROR IN ROOM 310 ARE ASSUMED ASBESTOS CONTAINING.
- EXTERIOR EXPANSION JOINTS, ROOFING MATERIALS, AND INFORMATION PROVIDED IN THE AHERA MAPS AND AHERA AND PORTICOS, AND MECHANICAL SYSTEMS USED TO CONDITION INTERIOR SPACE. THE FOLLOWING ARE EXAMPLES OF MATERIALS NEED TO BE COLLECTED AND ANALYZED. LICENSED ASBESTOS BUILDING INSPECTOR AND SAMPLES MAY AMPS A THOROUGH INSPECTION MUST BE PERFORMED BY A DISTURBING THE MATERIALS EXCLUDED FROM THE MAPS AND MATERIALS THAT MAY BE HIDDEN IN WALL CAVITIES. PRIOR TO THAT MAY BE EXCLUDED: EXTERIOR CAULKING AND GLAZING, INCLUDE EXTERIOR HALLWAYS CONNECTING BUILDINGS, PORCHES ASBESTOS MANAGEMENT PLANS (AMPS) IS LIMITED TO ACCESSIBLE MATERIALS IN INTERIOR SPACES. INTERIOR SPACES

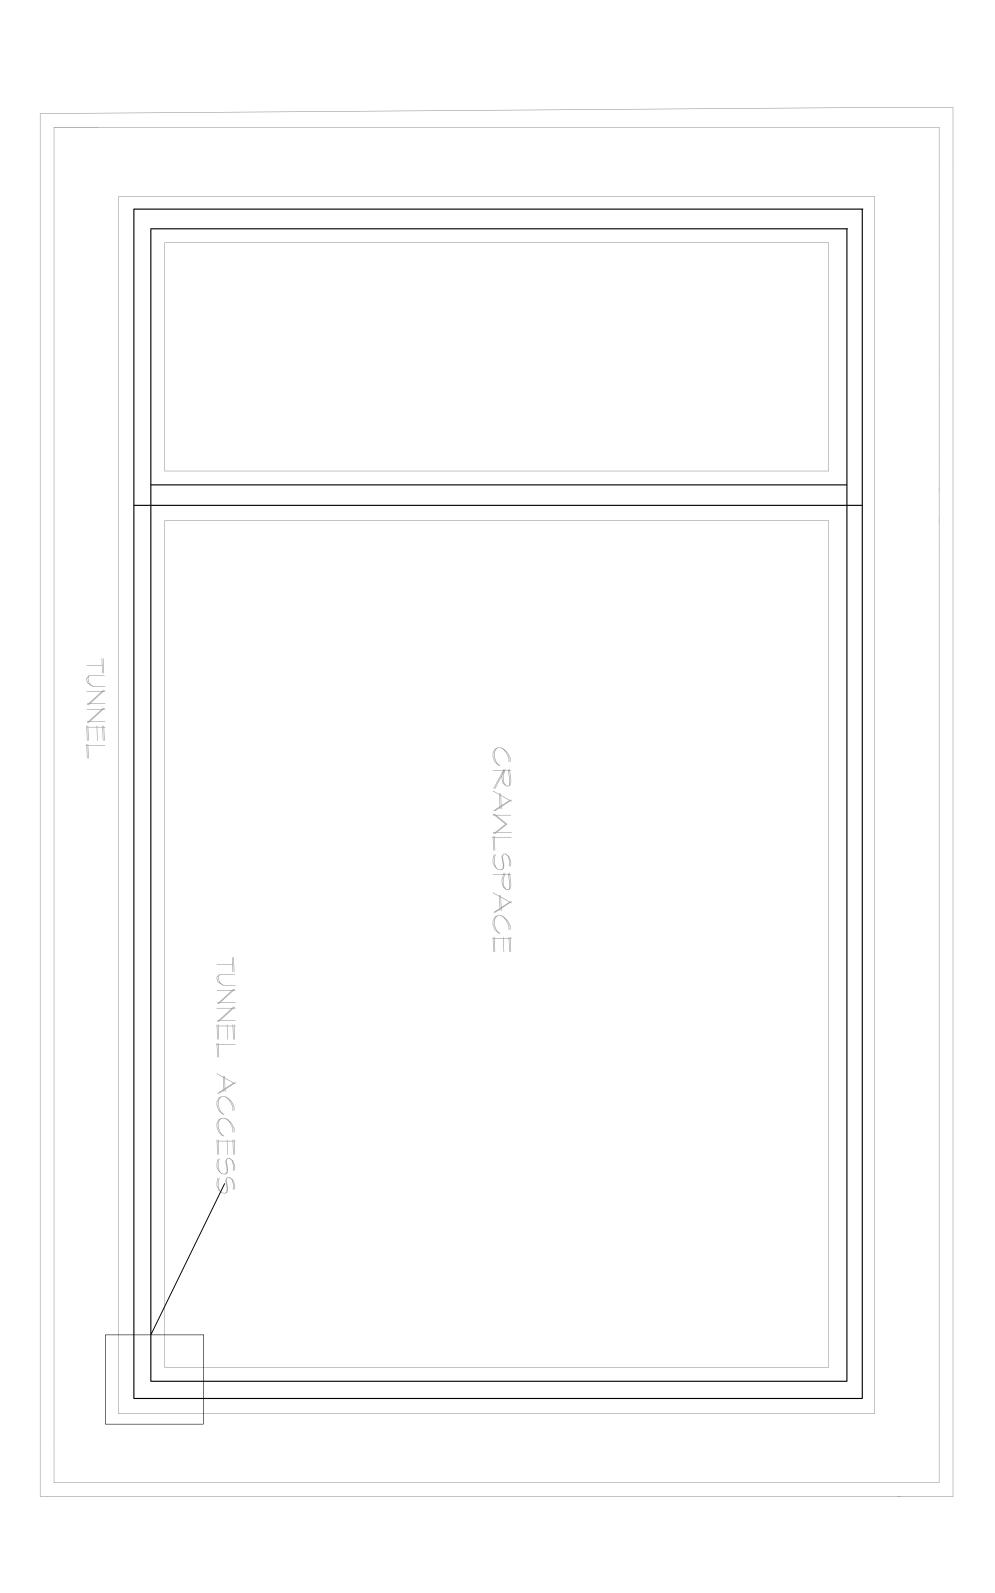
ASSUMED ASBESTOS CONTAINING WALL & CEILING TRANSITE PANELS

ASBESTOS CONTAINING TERRA 220

ABESTOS PIPE AND FITTING INSULATION

- **CONTAINING CORES** ALL FIRE DOORS ARE ASSUMED TO HAVE ASBESTOS
- 7 GLUE PADS BEHIND MIRROR IN ROOM 310 AND CORKBOARD IN ROOM 110 ARE ASSUMED ASBESTOS CONTAINING.

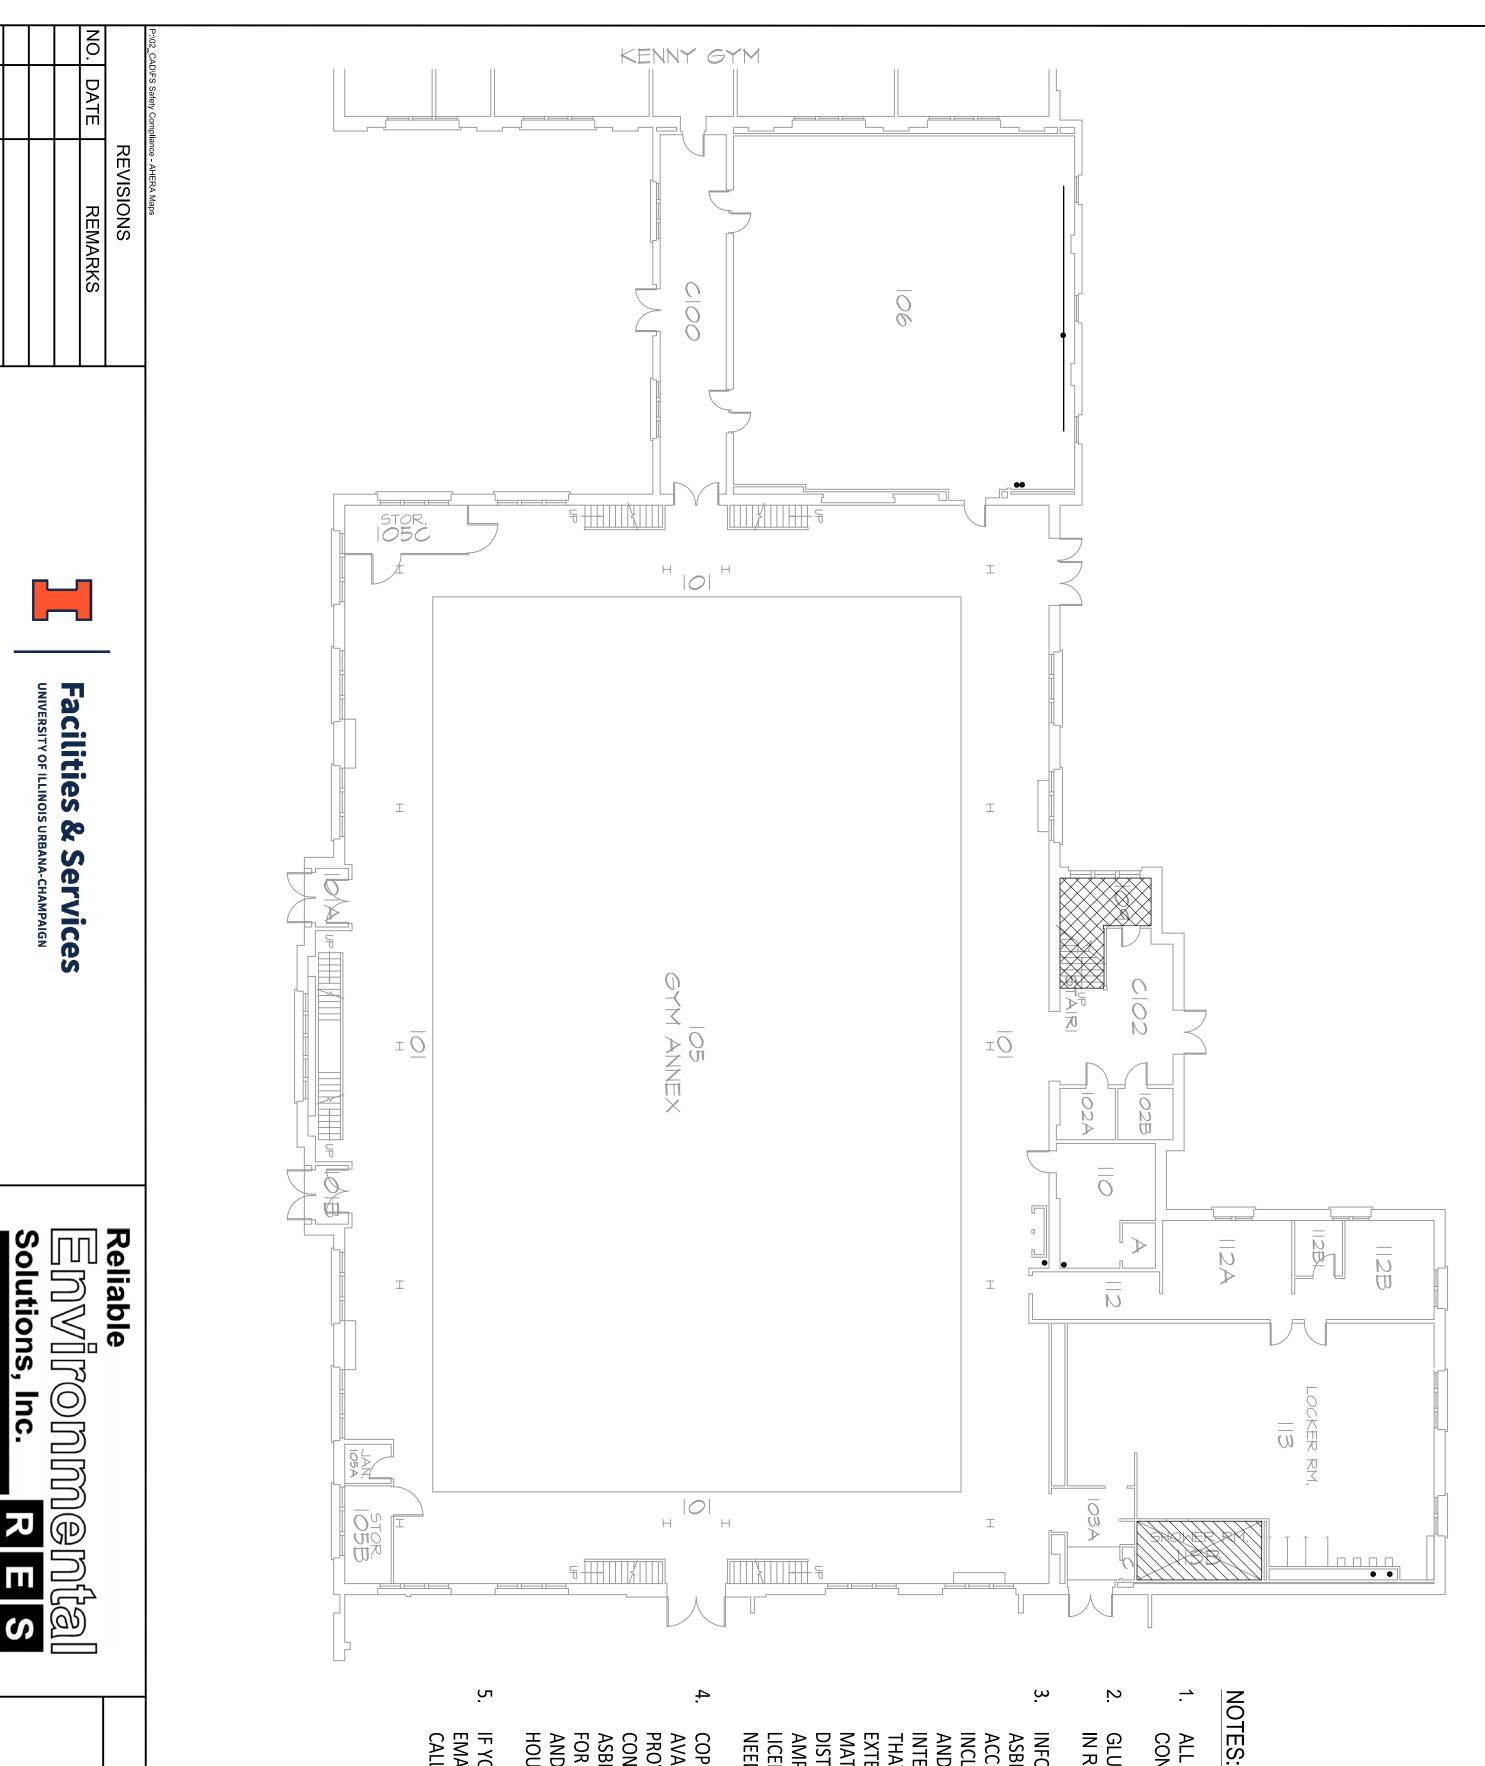
CONTAINING CORES ALL FIRE DOORS ARE ASSUMED TO HAVE ASBESTOS

ASSUMED ASBESTOS CONTAINING WALL & CEILING TRANSITE PANELS

ASBESTOS CONTAINING TERRA 220

ABESTOS PIPE AND FITTING INSULATION

- GLUE PADS BEHIND MIRROR IN ROOM 310 AND CORKBOARD IN ROOM 110 ARE ASSUMED ASBESTOS CONTAINING.
- AND PORTICOS, AND MECHANICAL SYSTEMS USED TO CONDITION INTERIOR SPACE. THE FOLLOWING ARE EXAMPLES OF MATERIALS THAT MAY BE EXCLUDED: EXTERIOR CAULKING AND GLAZING, EXTERIOR EXPANSION JOINTS, ROOFING MATERIALS, AND MATERIALS THAT MAY BE HIDDEN IN WALL CAVITIES. PRIOR TO NEED TO BE COLLECTED AND ANALYZED. LICENSED ASBESTOS BUILDING INSPECTOR AND SAMPLES MAY AMPS A THOROUGH INSPECTION MUST BE PERFORMED BY A DISTURBING THE MATERIALS EXCLUDED FROM THE MAPS AND INCLUDE EXTERIOR HALLWAYS CONNECTING BUILDINGS, PORCHES ASBESTOS MANAGEMENT PLANS (AMPS) IS LIMITED TO INFORMATION PROVIDED IN THE AHERA MAPS AND AHERA ACCESSIBLE MATERIALS IN INTERIOR SPACES. INTERIOR SPACES

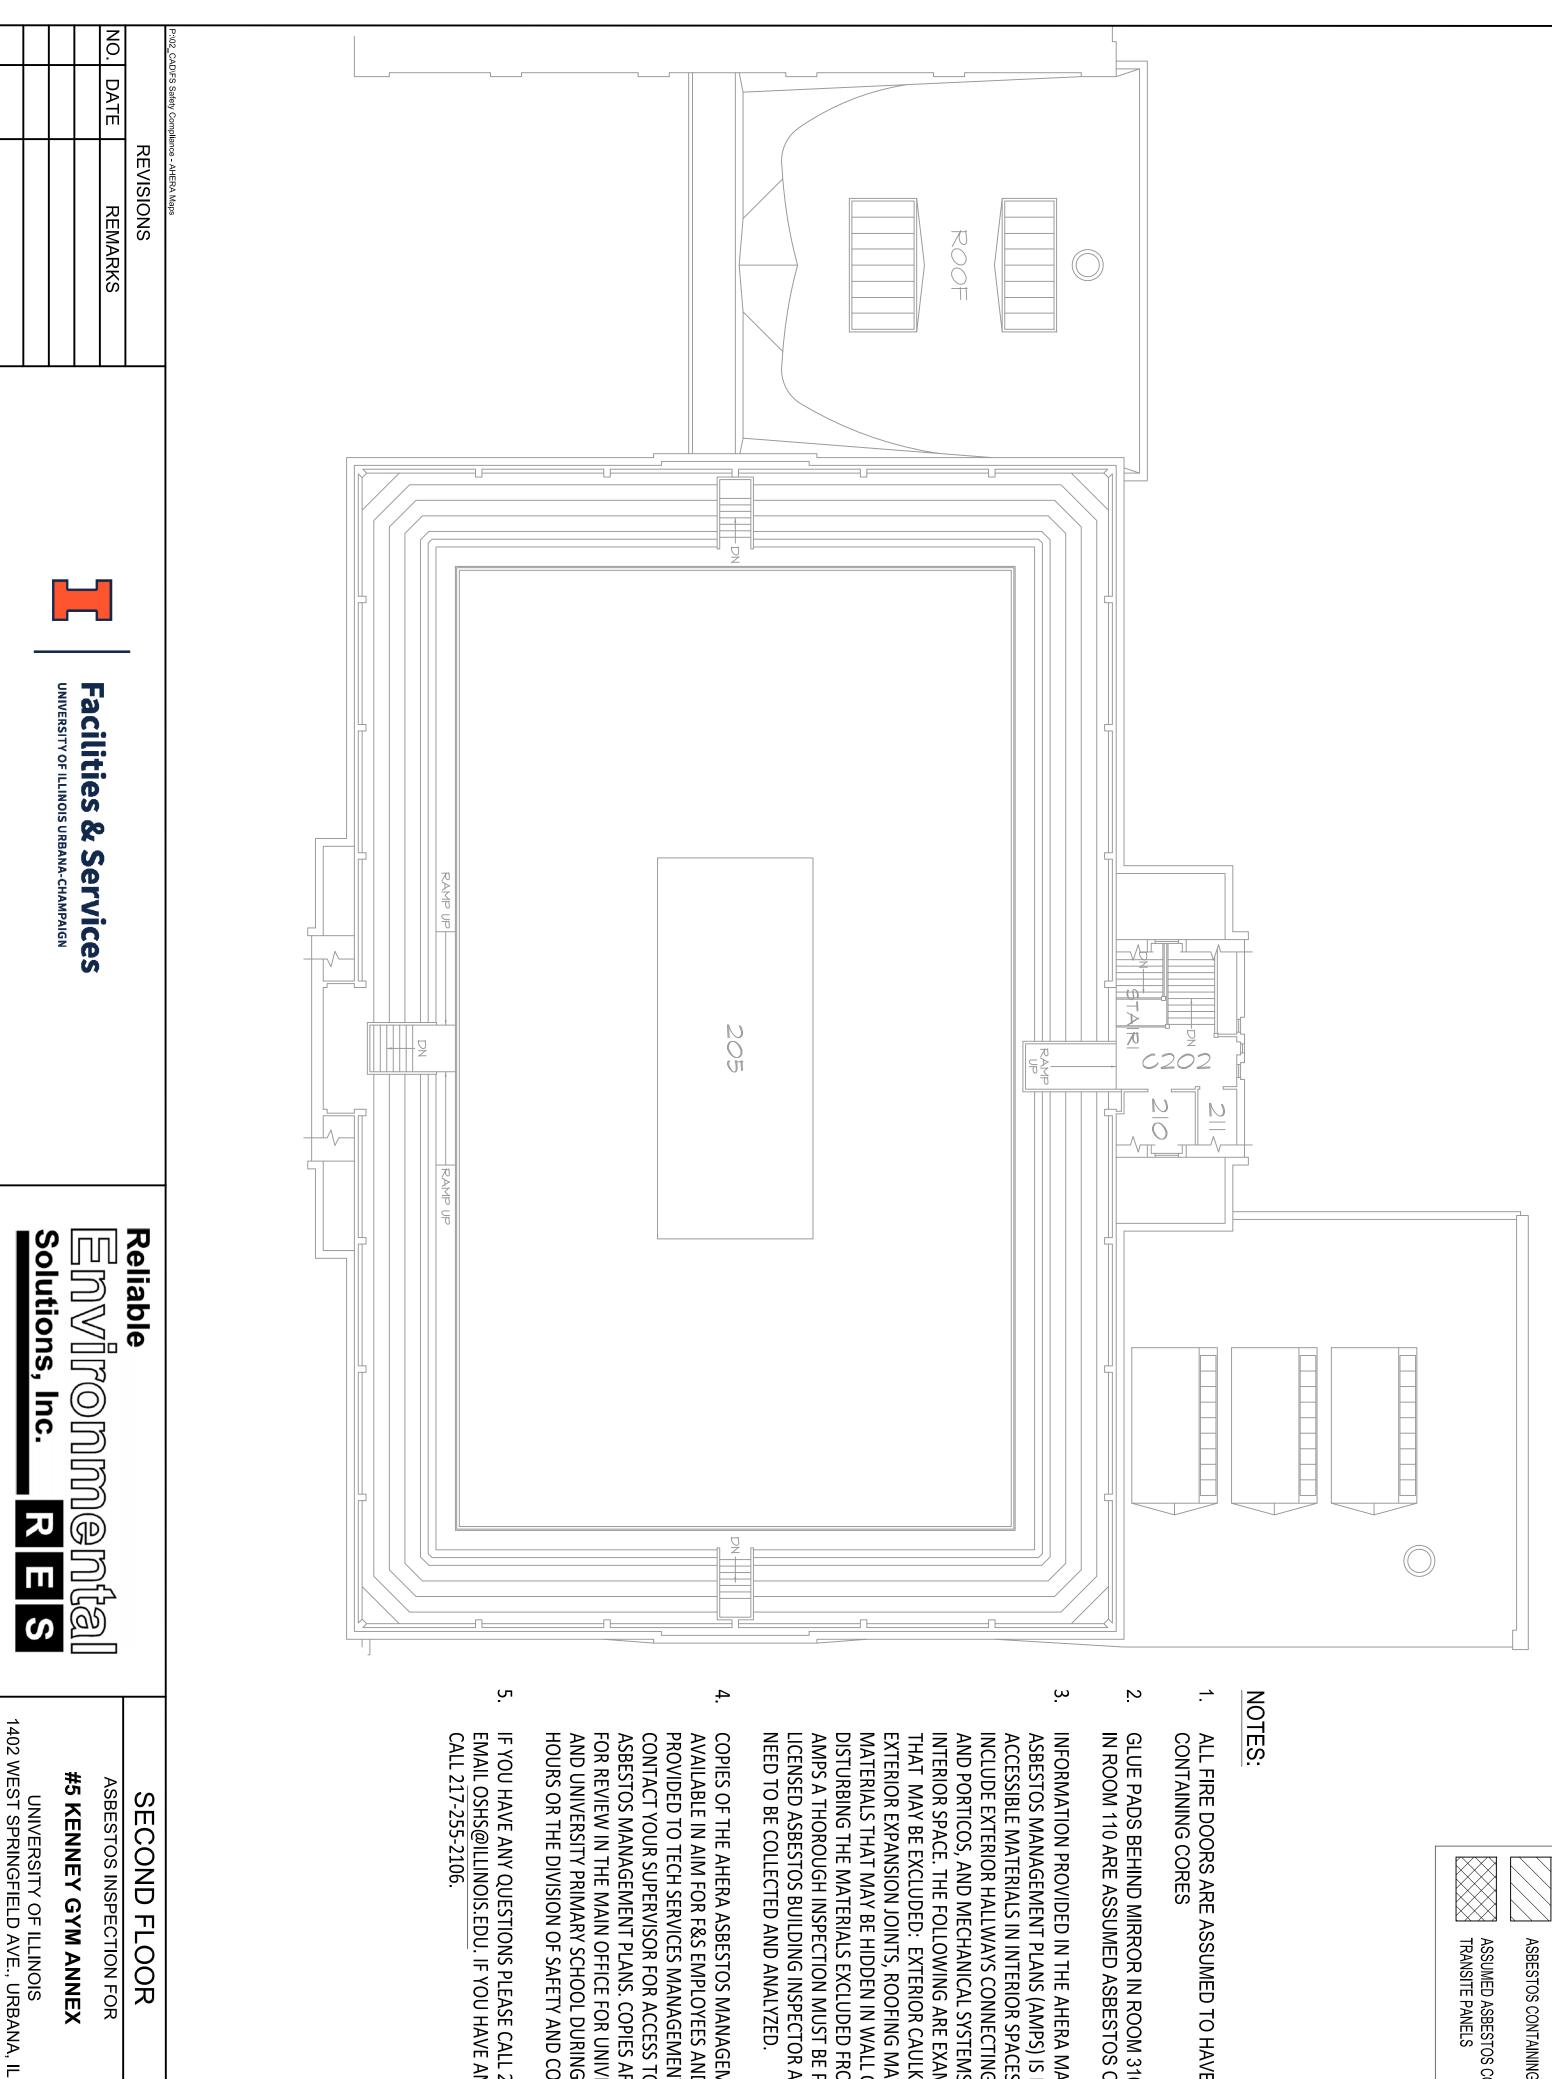
SECOND FLOOR

ASSUMED ASBESTOS CONTAINING WALL & CEILING TRANSITE PANELS

ASBESTOS CONTAINING TERRA 220

ABESTOS PIPE AND FITTING INSULATION

- **CONTAINING CORES** ALL FIRE DOORS ARE ASSUMED TO HAVE ASBESTOS
- GLUE PADS BEHIND MIRROR IN ROOM 310 AND CORKBOARD IN ROOM 110 ARE ASSUMED ASBESTOS CONTAINING.
