ADA TRANSITION PLAN 2017 SUPPLEMENT

Supplement to the ADA Transition Plan

Accessibility for Public Right-of-Way and Exterior Accessible Routes for Buildings University of Illinois at Urbana-Champaign May 2017

Prepared by Facilities & Services, Engineering and Construction Services Division

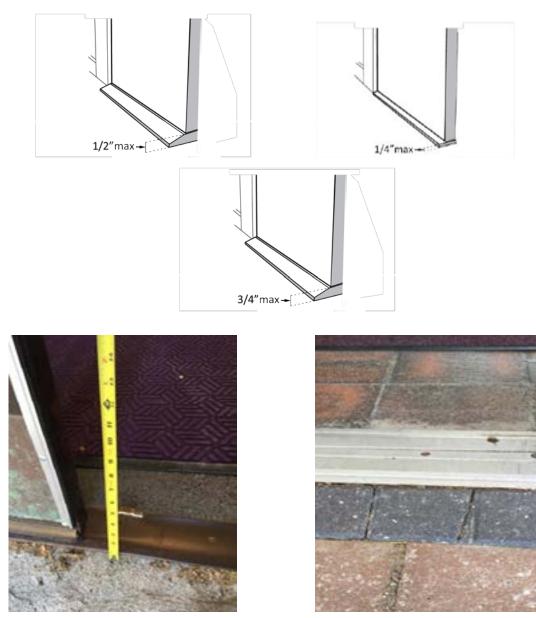
Figure 18- High Threshold

Figure 19- Difficul Stone Threshold

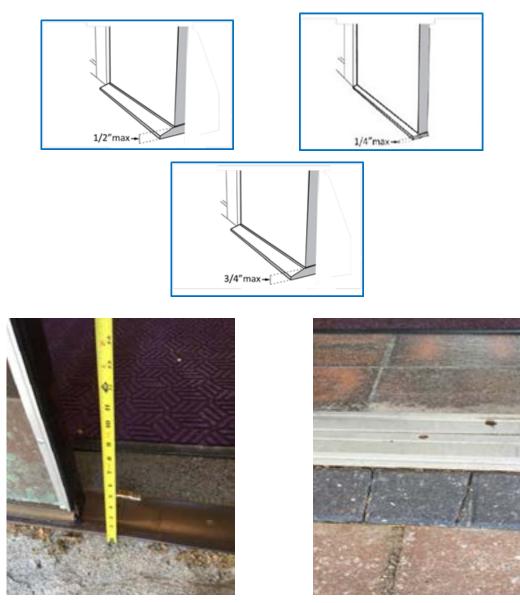
Figure 18- High Threshold

Figure 19- Difficult Stone Threshold

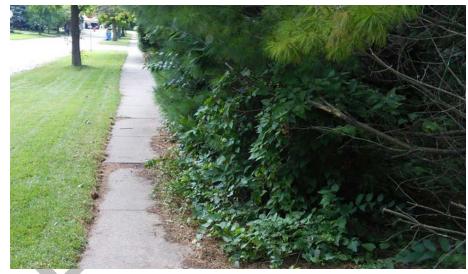
In this block of sidewalk, vegetation overgrowth acts as an obstruction and reduces the passable width to 39 inches. The largest vertical fault on the block is over $\frac{1}{2}$ inch, and the maximum cross slope is 10 percent, resulting in a combined compliance score of 15.

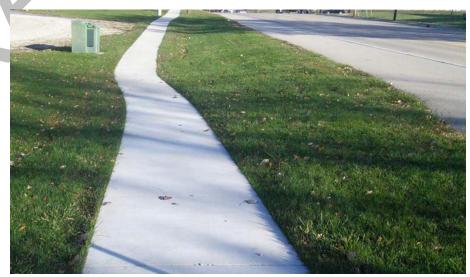
This block of sidewalk is 60 inches wide and has no vertical faults or obstructions. With a maximum cross slope of 2.3 percent, it scores 95 on the combined compliance index.

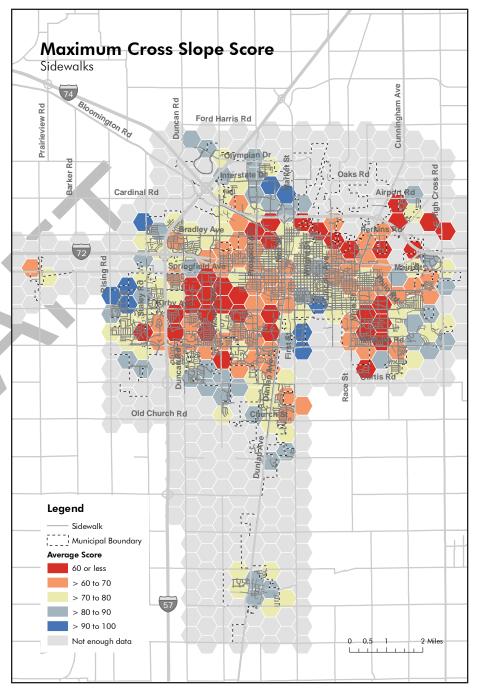
Figure 4-2 Sidewalk Cross Slope Scores

Maximum sidewalk cross slopes were highest in older residential neighborhoods with frequent driveway crossings (see *Figure 4-2*). Downtowns, commercial areas, and newer residential neighborhoods had lower maximum cross slopes. The University of Illinois campus area had lower maximum sidewalk cross slopes than most other parts of the urbanized area, though on average, many parts of the of the campus still exceeded the 2.0 percent PROWAG threshold.

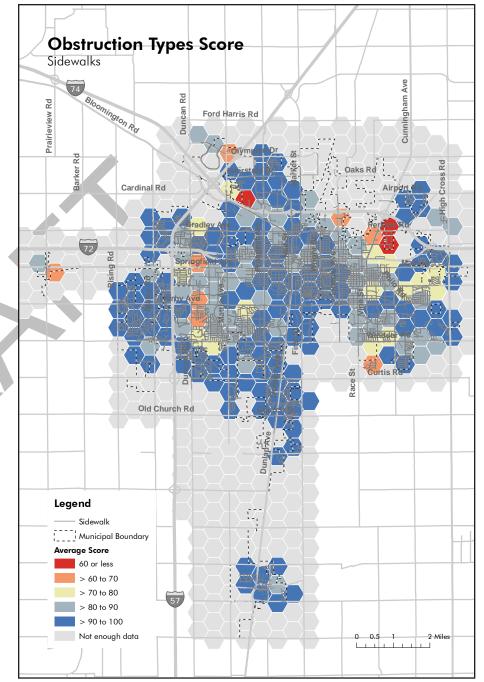
Figure 4-4 Sidewalk Obstruction Scores

Less than 20 percent of sidewalks by length had an obstruction, and only about one percent had more than one type of obstruction. Tree trunk or other vegetation was the most common type of obstruction, followed by other obstructions, such as gravel, street furniture, or planters. Areas with high concentrations of sidewalk obstructions included the Duncan Road corridor and Dobbins Downs area in Champaign; and the Cunningham Avenue corridor, East Washington Street corridor, and Meadowbrook Park area in Urbana (see Figure 4-4).

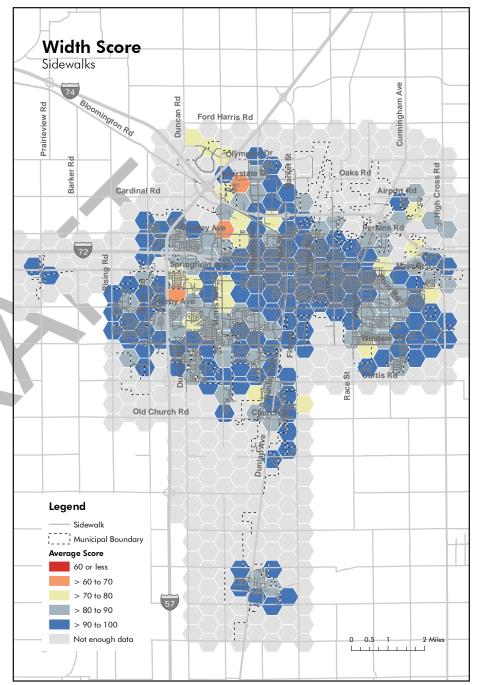
Figure 4-5 Sidewalk Width Scores

Areas where sidewalk width was most problematic included central Champaign between I-57 and Mattis Avenue; north Champaign between Mattis and Prospect Avenues; and scattered areas in Urbana and Savoy (see *Figure 4-5*). Sidewalk width was higher in the central part of the urbanized area and in newer developments along the fringe.

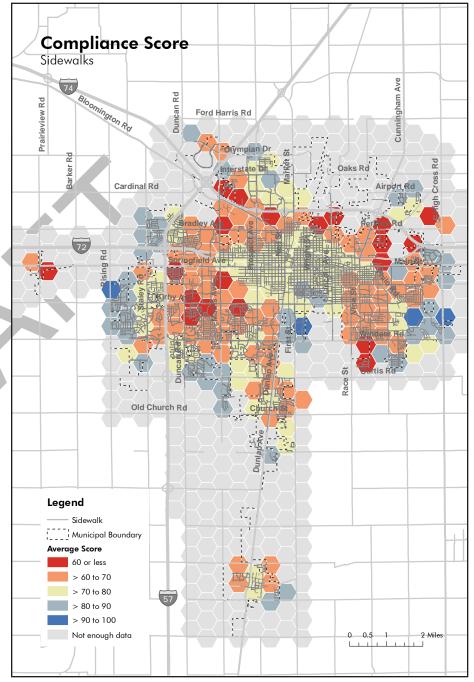
Figure 4-6 Sidewalk Compliance Scores

Preliminary ADA compliance was relatively low overall, with only about 8 percent of sidewalks by length scoring above 90 on the compliance index (see *Table 4-7*). More than half of the total sidewalk length in the urbanized area scored below 70 on the index. Compliance was highest at the fringe of the urbanized area, followed by the core of the community (see *Figure 4-6*). The ring of residential neighborhoods constructed in the mid to late twentieth century had the lowest levels of compliance, a pattern visible in Champaign-Urbana-Savoy and in Tolono.

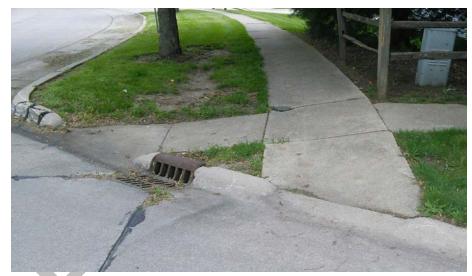
With multiple accessibility issues, this ramp scores 31 on the combined compliance index. The ramp lacks a detectable warning surface, the left approach is obstructed by a water valve, and many of the cross slopes are 10 percent or above.

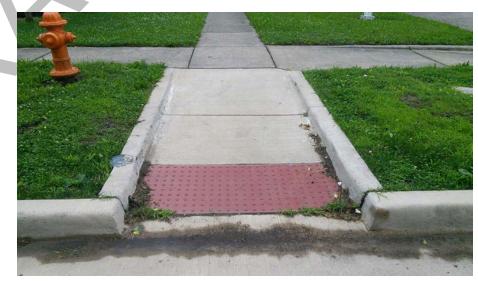
With a width of 60 inches, a minimum landing dimension of 48 inches, truncated domes that fill the width of the ramp, and all slopes within the compliant ranges, this ramp scores 100 on the combined compliance index.

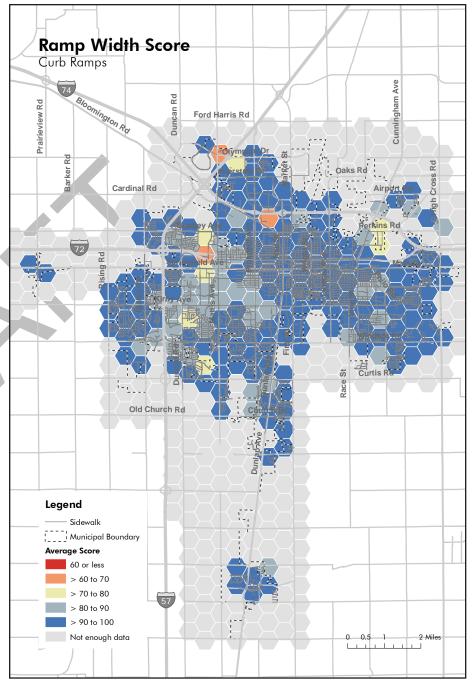
Figure 4-8 Curb Ramp Width Scores

Nearly 84 percent of curb ramps measured met the PROWAG standard for width. Less than 3 percent of all ramps were less than 42 inches wide. Areas with higher levels of noncompliant ramp width included central Champaign between I-57 and Mattis Avenue, north Champaign near the I-57/Olympian Drive interchange, and north Urbana near the I-74/Cunningham Avenue interchange (*Figure 4-8*).

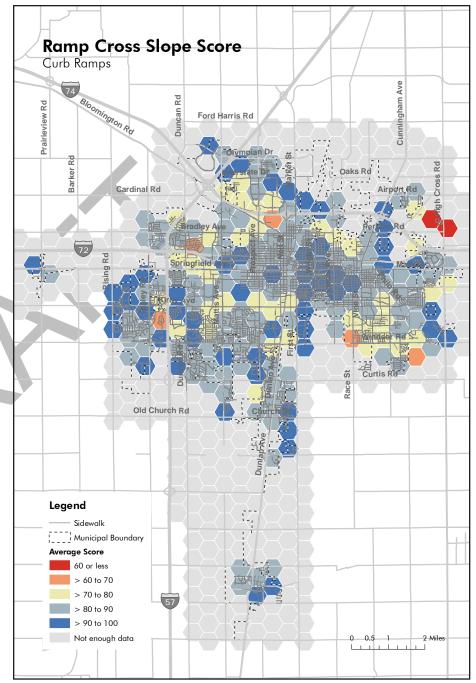
Figure 4-9 Curb Ramp Cross Slope Scores

High average ramp cross slopes occurred in scattered pockets across the urbanized area, particularly in north and central Champaign and in south Urbana (see *Figure 4-9*). The highest average ramp cross slopes occurred near the intersection of Perkins Road and High Cross Road, an area with relatively few curb ramps.

The scattered pattern of problematic ramp cross slopes suggests that these cross slopes were the result of specific construction practices and standards used in particular developments rather than the time at which the ramp was built. However, the most recently developed areas also tended to have higher levels of compliance. On average, the University of Illinois campus area, west Champaign, and south Savoy had relatively low ramp cross slopes, reflecting the higher proportion of recently constructed curb ramps in these areas.

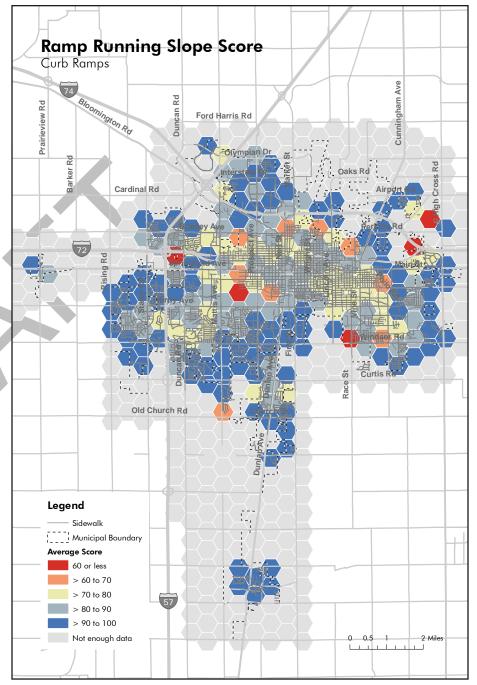
Figure 4-10 Curb Ramp Running Slope Scores

Approximately 70 percent of curb ramps in the urbanized area had running slopes within the range allowed by PROWAG, and nearly 8 percent were exempt from the running slope requirement because their length exceeded 15 feet. However, almost 10 percent of ramps had running slopes greater than 10.3 percent, or two percent above the allowed threshold.

Unlike ramp cross slope, high ramp running slopes were most common in the central part of the urbanized area, particularly in some of the oldest residential neighborhoods in Champaign and Urbana (see *Figure 4-10*). This spatial pattern likely reflects changing understandings of what constitutes a safe ramp slope for all users and the corresponding evolution of standards.

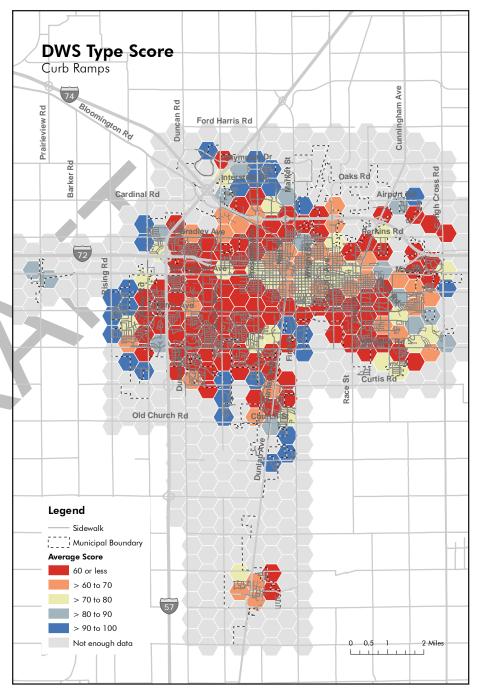
Figure 4-11 Curb Ramp Detectable Warning Surface Type Scores

Of curb ramps requiring a detectable warning surface, about 22 percent had no detectable warnings at all. Of the remaining 88 percent, about half had truncated domes, and half had pavement grooves.

Truncated domes were most prevalent in the newest developments around the fringe of the urbanized area, reflecting the evolution in accessibility standards (see *Figure 4-11*). The University of Illinois campus area had more ramps with truncated domes than most other parts of Champaign and Urbana, but even there coverage remained incomplete.

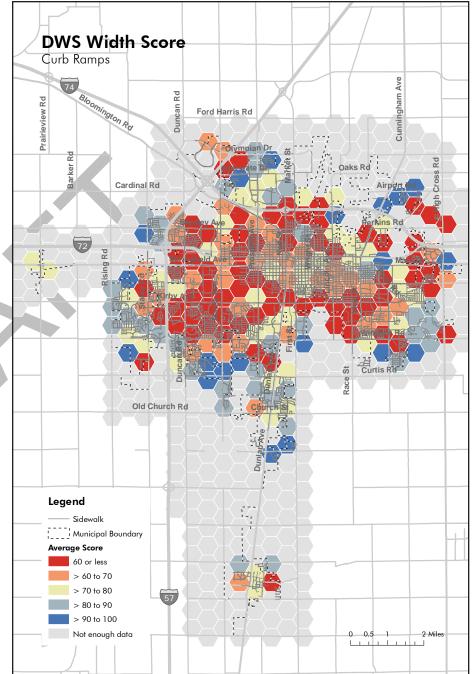
Figure 4-12 Curb Ramp Detectable Warning Surface Width Scores

Nearly 36 percent of curb ramps requiring detectable warnings had surfaces that met the PROWAG width requirement. Of ramps with truncated domes, about 53 percent met the width standard. Most ramps with narrower detectable warning surfaces had surfaces that were at least 80 percent of the required width.

The spatial pattern of detectable warning surface width compliance was similar to that of surface type, suggesting that the age of the ramp was a significant factor in determining compliance (see *Figure 4-12*). The areas with the highest levels of compliance were more recent developments on the periphery of the urbanized area, particularly on the south side of Champaign, Urbana, and Savoy.

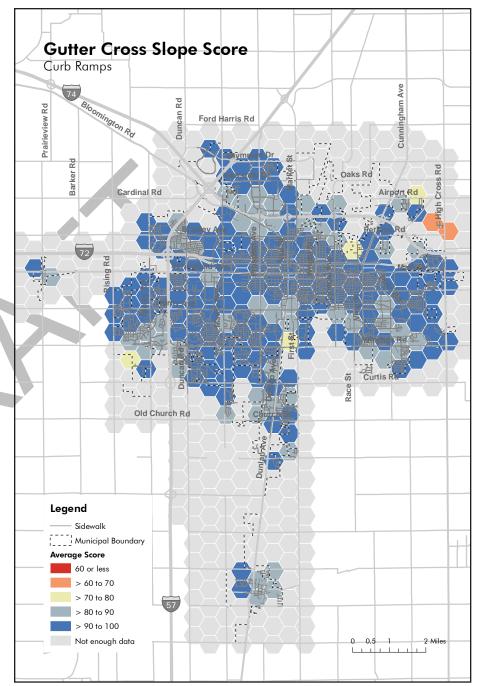
Figure 4-13 Curb Ramp Gutter Cross Slope Scores

More than 70 percent of curb ramps adjacent to the street had gutter slopes within the range allowed by PROWAG. Most of the noncompliant gutter cross slopes were 4 percent or less, suggesting that gutter cross slope presents fewer severe accessibility challenges than cross slopes in other parts of the sidewalk network.

Areas with lower levels of gutter cross slope compliance included areas north and south of I-74 in Champaign and Urbana; southwest Champaign west of I-57; Urbana south of Florida Avenue; and the U.S. 45/Dunlap Avenue corridor south of Kirby Avenue (see *Figure 4-13*).

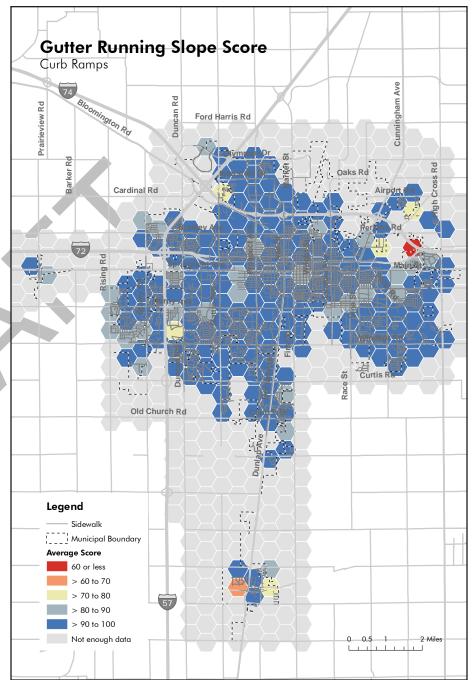
Figure 4-14 Curb Ramp Gutter Counter Slope Scores

Nearly 80 percent of curb ramps adjacent to the street had gutter counter slopes within the compliant range. Of higher gutter counter slopes, most were 9 percent or less. Only about four percent of ramps had gutter counter slopes greater than 9 percent.

Noncompliant gutter counter slopes were scattered throughout the urbanized area (see *Figure 4-14*). This spatial pattern suggested that noncompliance was primarily related to the properties of specific streets and gutters rather than systematic issues in street and gutter construction.

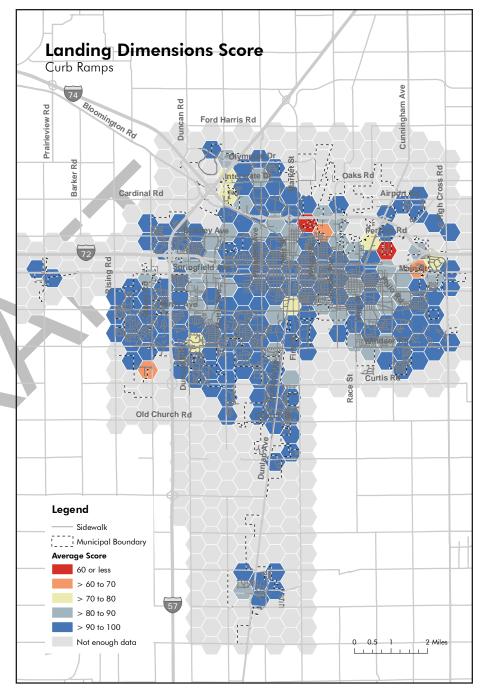
Figure 4-15 Curb Ramp Landing Dimensions Scores

Of curb ramps that required a landing, about 83 percent had a landing that met PROWAG standards for dimensions. However, nearly eight percent of ramps with running slopes greater than 5.0 percent lacked a flat landing area, requiring pedestrians to turn on the sloped ramp surface. Approximately nine percent of ramps had a landing area that was present but too small. Noncompliant landing dimensions were concentrated in the north and central portions of Champaign and Urbana (see Figure 4-15).

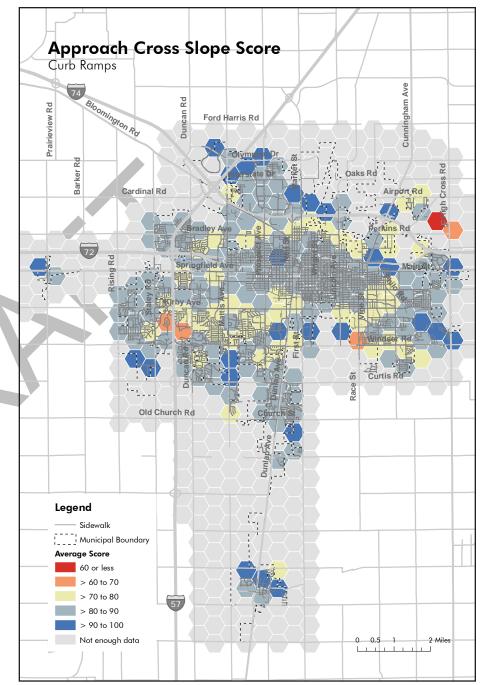
Figure 4-17 Curb Ramp Approach Cross Slope Scores

Less than 40 percent of ramps with approaches had maximum approach cross slopes within the compliant range. About 56 percent had a maximum approach cross slope between 2.1 and 6.0 percent. Higher approach cross slopes were relatively rare and often coincided with other flaws in the ramp design, such as intersecting ramps and high ramp cross slope.

Approach cross slope was most often compliant on the periphery of the urbanized area and in the core (see Figure 4-17). Compliance was lowest in the ring of mid to late twentieth century residential neighborhoods surrounding the core of the community.

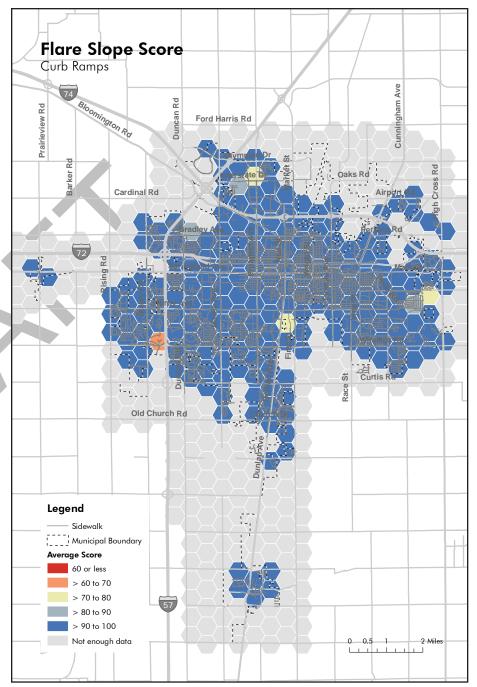
Figure 4-18 Curb Ramp Flare Slope Scores

Only 368 curb ramps had flared sides, and of these, about 40 percent had flare slopes within the compliant range. Almost 100 ramps, more than one quarter of the total with flares, had curb flare slopes greater than 18 percent. In many cases, these flares were not adjacent to a walkable surface and were designed to function as returned curbs. However, the steep slope and lack of a distinct, cane-detectable curb made them a potential safety hazard, particularly for blind or low-vision pedestrians.

Because of the small number of ramps with curb flares, no spatial pattern in flare slope compliance was evident (see *Figure 4-18*).

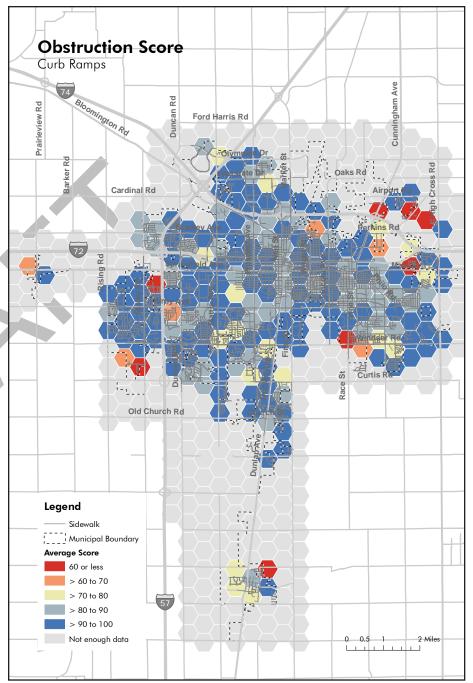
Figure 4-20 Curb Ramp Obstruction Scores

Approximately 90 percent of curb ramps in the urbanized area were free from obstructions, while about 10 percent had at least one type of obstruction present. The most common types of obstructions were other obstructions such as insufficiently depressed curbs; grates and manhole covers; and tree trunks or other vegetation (see Table 4-21).

Areas with high concentrations of curb ramp obstructions were scattered throughout the urbanized area and included the northeast corner of the urbanized area along I-74, the Windsor Road corridor in Urbana, some areas along I-57 in southwest Champaign, and fringe areas of Tolono (see *Figure 4-20*).

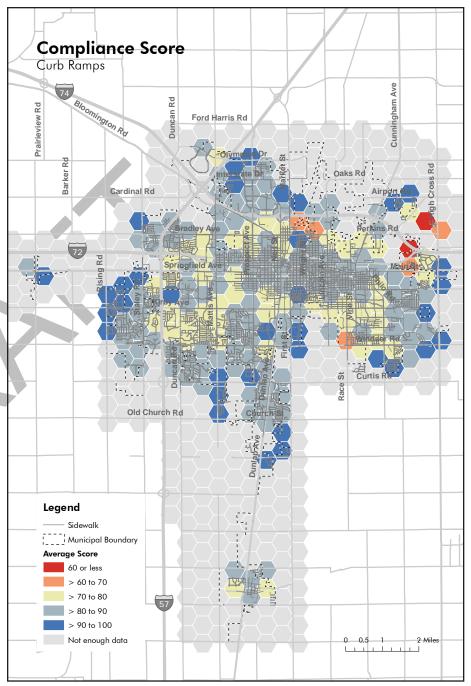
Figure 4-21 Curb Ramp Compliance Score

Overall, curb ramp compliance scores were higher than sidewalk compliance scores, with about 36 percent of features scoring higher than 90 on the combined compliance index (see *Table 4-23*). More than 83 percent of curb ramps scored above 70 on the compliance index. The higher scores are due in part to the lower average age of curb ramps relative to sidewalks. They also reflect consistently high scores on certain components of the index, such as gutter slopes and landing dimensions, which inflated the combined compliance score of many features.

The combined compliance scores were highest on average in newly-constructed developments at the fringe of the community (see *Figure 4-21*). These consistently high scores appeared on virtually all sides of the urbanized area, including north, west, and south Champaign; east Urbana; and Savoy. Ramps in these areas tended to be newer, on average, and conformed more closely to the current PROWAG standards, particularly with regard to the use of truncated domes.

In some cases, such as ramps that are missing truncated domes, it may be possible to retrofit the noncompliant ramps to bring them into compliance with PROW-AG standards. Other problems, such as incorrect geometry in the ramp and approaches, may require total reconstruction of the ramp area. In such cases, it may be necessary to replace one ramp type with a different type, such as replacement of a perpendicular ramp with combination ramps, in order to remedy overly steep ramp runs.

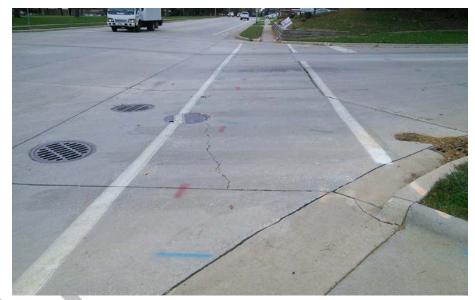
With a width of 92 inches and a cross slope of 6.3 percent, this crosswalk at a stop-controlled intersection scores 70 on the combined compliance index.

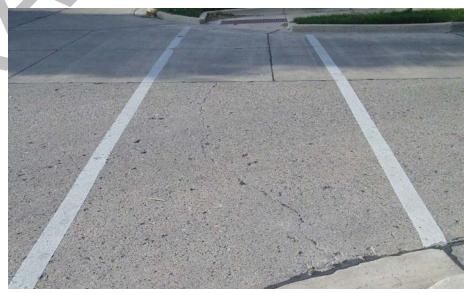
This crosswalk at an uncontrolled intersection scores 100 on the compliance index due to its width of 91 inches and its cross slope of 0.7 percent.

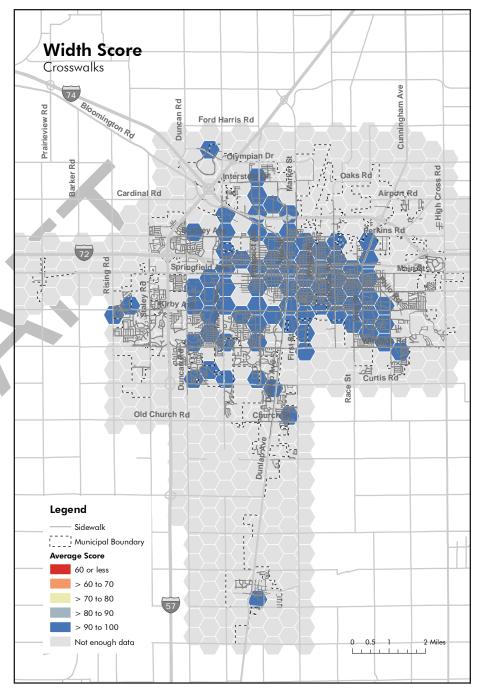
Figure 4-23 Crosswalk Width Scores

All of the crosswalks measured had a width of at least four feet. Marked crosswalks are most prevalent in core of the community, including the downtowns of Champaign and Urbana and the University of Illinois campus area (see *Figure* 4-23).

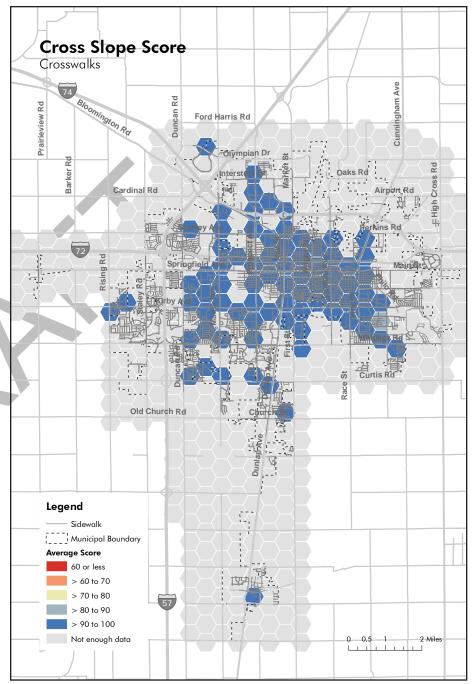
Figure 4-24 Crosswalk Cross Slope Scores

Approximately 94 percent of crosswalks at intersections had a cross slope within the compliant range. Most of the remaining intersection crosswalks had cross slopes in the second score tier, while extreme cross slopes were relatively rare. Because of the high level of compliance, no spatial pattern is evident in the cross slope compliance scores (see *Figure 4-24*).

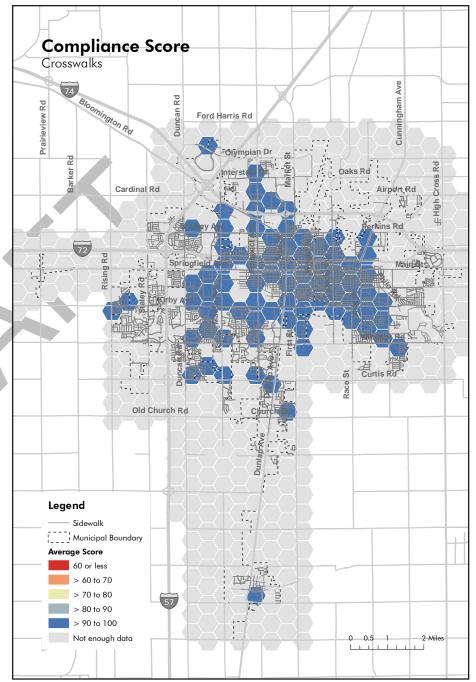
Figure 4-25 Crosswalk Compliance Scores

Nearly 95 percent of crosswalks scored above 90 on the compliance index, and more than 99 percent scored above 80 (see *Table 4-28*). The high scores reflect the limited set of variables available for assessing crosswalk compliance as well as the high level of compliance on the criteria examined. Because of the high level of compliance among crosswalks, no spatial pattern was evident in the compliance results (see *Figure 4-25*).

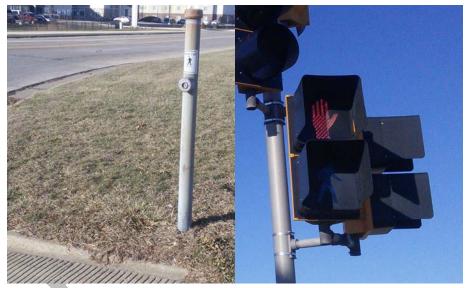
With a small pushbutton that lacks a tactile arrow, vibrotactile indicator, locator tone, and most other accessibility features, this pedestrian signal scores 40 on the combined compliance index.

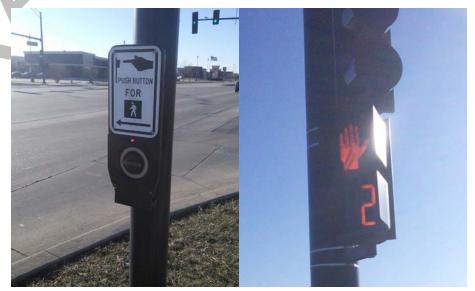
Figure 4-26 Pedestrian Signal Compliance Score Examples

Though the signal itself is similar to the previous example, this pushbutton has all of the required accessibility features and scores 100 on the compliance index.

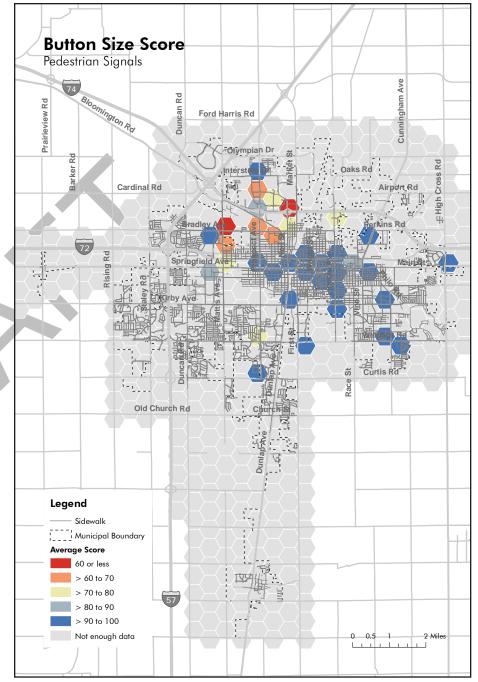
Figure 4-27 Pedestrian Signal Button Size Scores

Approximately 72 percent of pedestrian signals with pushbuttons were accessible based on button size. Less than 10 percent of pushbuttons were the smallest, least accessible button size. Accessible pushbuttons were least common on the north side of the urbanized area and in the Mattis Avenue corridor (see Figure 4-27).

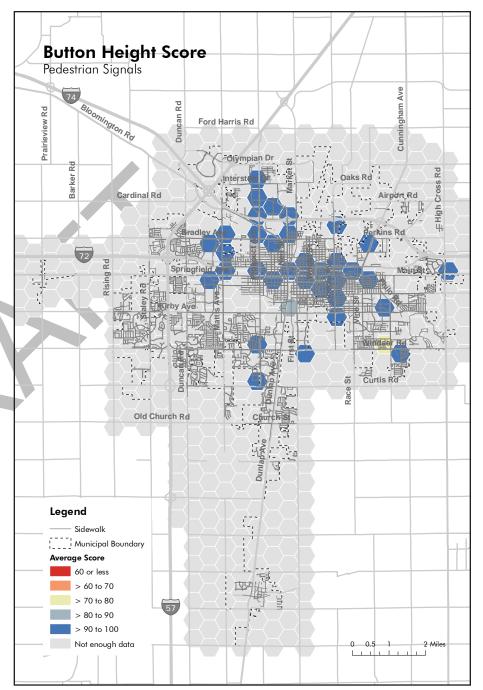
Figure 4-28 Pedestrian Signal Button Height Score

More than 93 percent of pedestrian pushbuttons were mounted at an accessible height, and no pushbuttons were located too low. Approximately 6 percent of pushbuttons were located between one and ten inches too high. Because of the high level of compliance for button height, no spatial pattern was evident (see *Figure 4-28*).

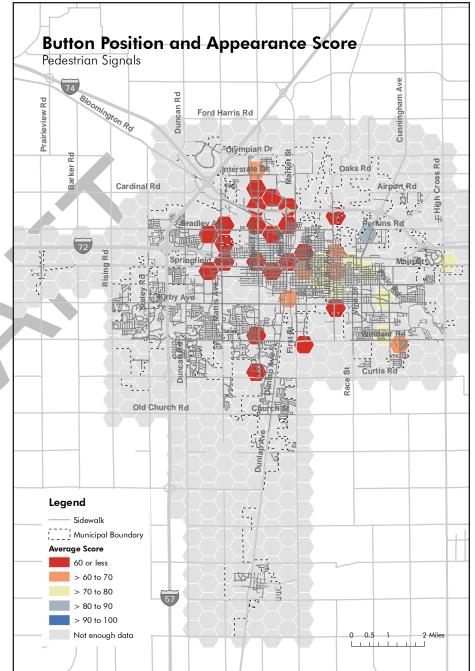
Figure 4-29 Pedestrian Signal Button Position and Appearance Scores

Placement near the curb and high contrast were the most common accessibility features, present in approximately 86 and 67 percent of pushbuttons, respectively. Placement away from other buttons and all-weather surfaces were less common, while locator tones were the rarest accessibility feature, present in only about one quarter of pushbuttons.

Pushbutton accessibility features were most common in Urbana, in and around the University of Illinois campus, and in some parts of the North Prospect Avenue shopping district (see *Figure 4-29*).

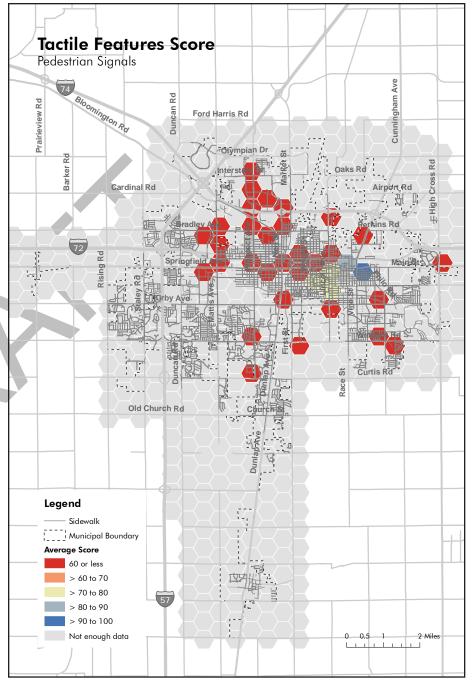
Figure 4-30 Pedestrian Signal Tactile Features Scores

Tactile features were relatively rare. Tactile arrows were present at only about 41 percent of pedestrian signals, and vibrotactile indicators were available at less than one quarter of signals. These features were most likely to be present in downtown Urbana and in the University of Illinois campus area (see Figure 4-30).

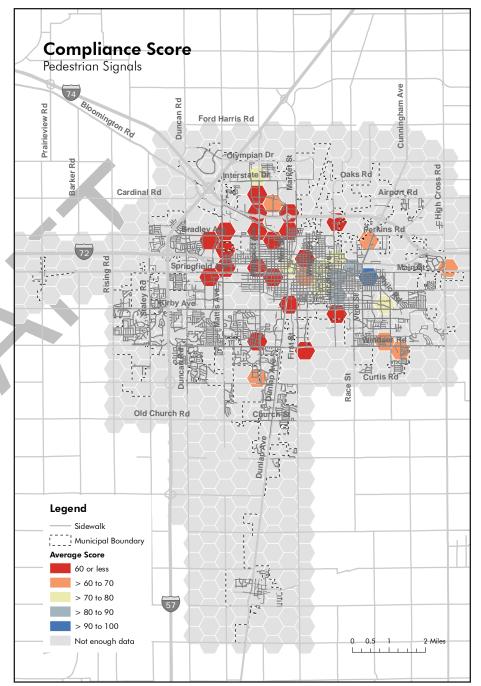
Figure 4-31 Pedestrian Signal Compliance Scores

Overall compliance scores for pedestrian signals were low, with only about one third of all pedestrian signals scoring above 70 on the compliance index (see *Table 4-34*). Nearly half of the pedestrian signals in the inventory scored 60 or lower on the index. The low scores reflect the difficulty and expense of incorporating all of the required accessibility features, particularly when pushbuttons are present.

Pedestrian signal compliance scores were highest in the core of the community, particularly in downtown Urbana and in the University of Illinois campus area (see *Figure 4-31*). Pedestrian signals along outlying arterials, such as Mattis Avenue and Bradley Avenue, had relatively low compliance scores.

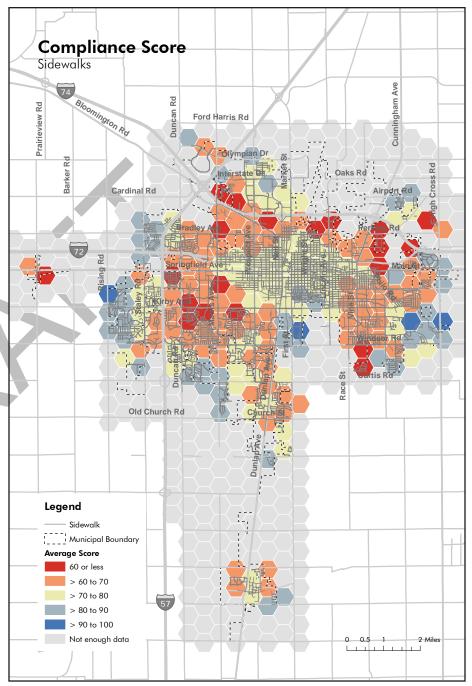
Figure 4-32 Comparison of Compliance Scores by Feature Type

The ring of noncompliance is significantly narrower for curb ramps than for sidewalks, suggesting that ramps were added to some neighborhoods after the initial construction of sidewalks. Bondville, where sidewalk compliance is low and curb ramp compliance is high, also exhibits this trend.

Pedestrian signals display a spatial pattern similar to sidewalks and curb ramps, except that compliance is highest at the center, rather than the fringe, of the urbanized area. Unlike for sidewalks and curb ramps, where the core of compliance is centered on the University of Illinois campus, the highest level of compliance for pedestrian signals is located in Urbana, east of the campus area.

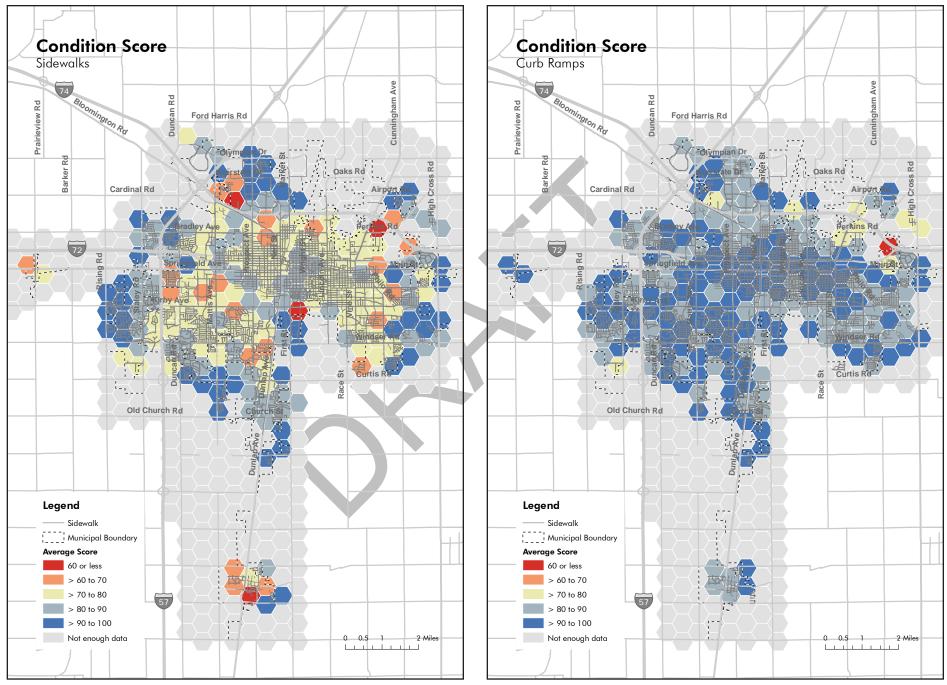
The spatial pattern of sidewalk condition scores was similar to that of sidewalk compliance scores, suggesting that ADA compliant sidewalks tend to be newer and in better condition than noncompliant sidewalks (see *Figure 5-7*). As with compliance, condition scores were highest at the fringe of the urbanized area, followed by the core of the community.

Curb ramp condition scores were more scattered with less of a recognizable spatial pattern (see *Figure 5-8*). Areas that scored poorly on sidewalk condition did not necessarily correspond to those with curb ramps in poor condition, suggesting that in some areas, the curb ramps were newer than the adjacent sidewalks. This pattern reflects the compliance mechanism in ADA, which requires curb ramp updates in conjunction with roadway modifications but does not require the replacement of adjacent sidewalks.

The results of the condition analysis suggest that most sidewalk condition issues can be addressed in conjunction with compliance updates. For curb ramps, however, separate maintenance efforts may be necessary to address curb ramps that are nearly or fully compliant with PROWAG standards but that suffer from surface condition issues.

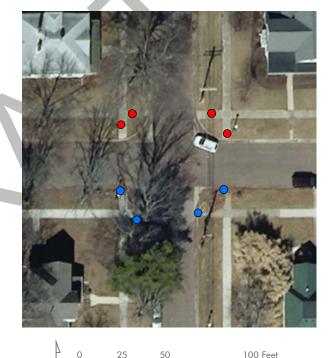
Missing Curb Ramps

This intersection has curbs on both sides but curb ramps only on the south side. Fifty percent of the possible curb ramp locations currently have ramps.

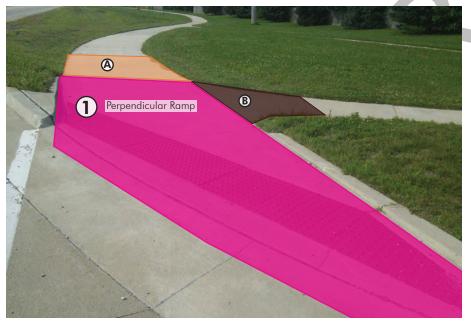
Figure A-3 Single Perpendicular Ramp without a Landing

There is no landing, or flat turning space, at this corner (see *Figure A-3*). The apparent ramp type is recorded as perpendicular because of the shape and orientation of the ramp. However, the ramp may be evaluated under the PROWAG standards for blended transitions, which do not require a landing, depending on its running slope.

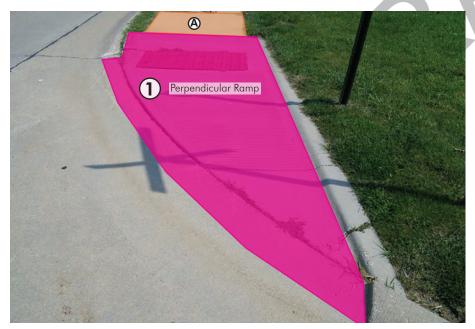
Figure A-5 Curb Ramp with Multiple Detectable Warning Surfaces

Some curb ramps include both truncated domes and pavement grooves (see *Figure A-5*). Since truncated domes are the compliant type, they are measured for the detectable warning surface fields. In such cases, the presence of pavement grooves can be noted in the feature comments.
